STRUCTURAL INSPECTION OF RIVERSIDE DAM INSPECTION REPORT

OCTOBER 16, 2024

PROJECT NO.: CA0037400.3034.
DATE: OCTOBER 16, 2024

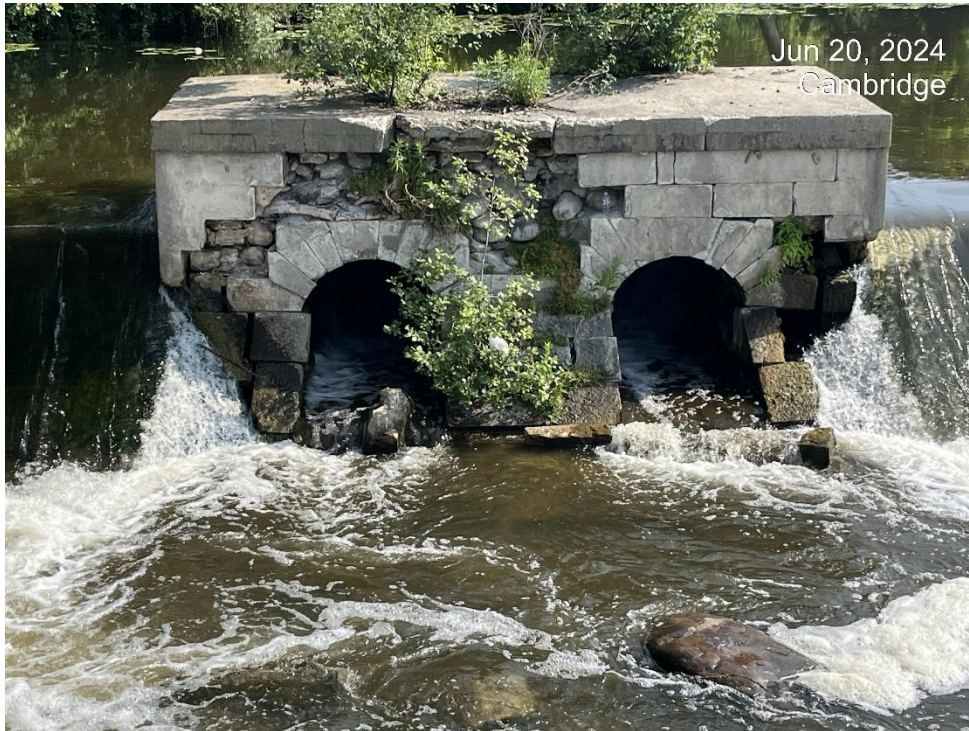
The north stop log structure is a masonry structure with significant sections of the front face missing. The exposed core consists of varying sizes of boulder/cobble rocks with a low strength cement mortar. The joints have opened, and vegetation is growing through the open joints. Several large masonry blocks from the fascia are missing, and others are on the verge of falling off the structure. No loss of blocks was observed since the 2022 inspection. Appendix B provides comparison photos between the 2022 and 2024 inspections.

Photo 1 - Elevation View of North Stop Log Structure

1. For the North Stop Log Structure, it is recommended that the raceways be blocked up as was previously done for the South Stop Log Structure as failure of the stop log structure would compromise the integrity of the dam. The details of this work would need to be determined through a separate design assignment.

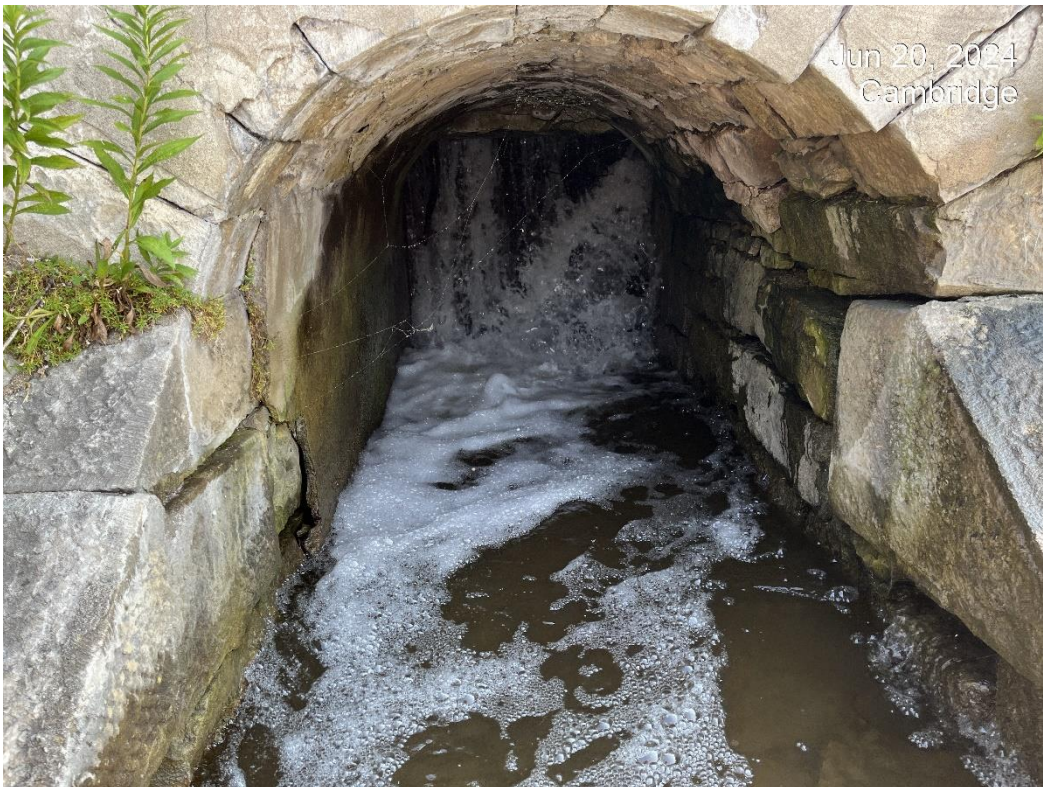
The timber stop logs are closed; however, they are leaking (refer to Photo 2), resulting in a small flow of water through the raceways. This is typical at both raceways (arches shown in Photo 1) on the North structure. The wooden stop logs appear to be in poor condition.

Photo 2 – Timber Stop Logs Leaking

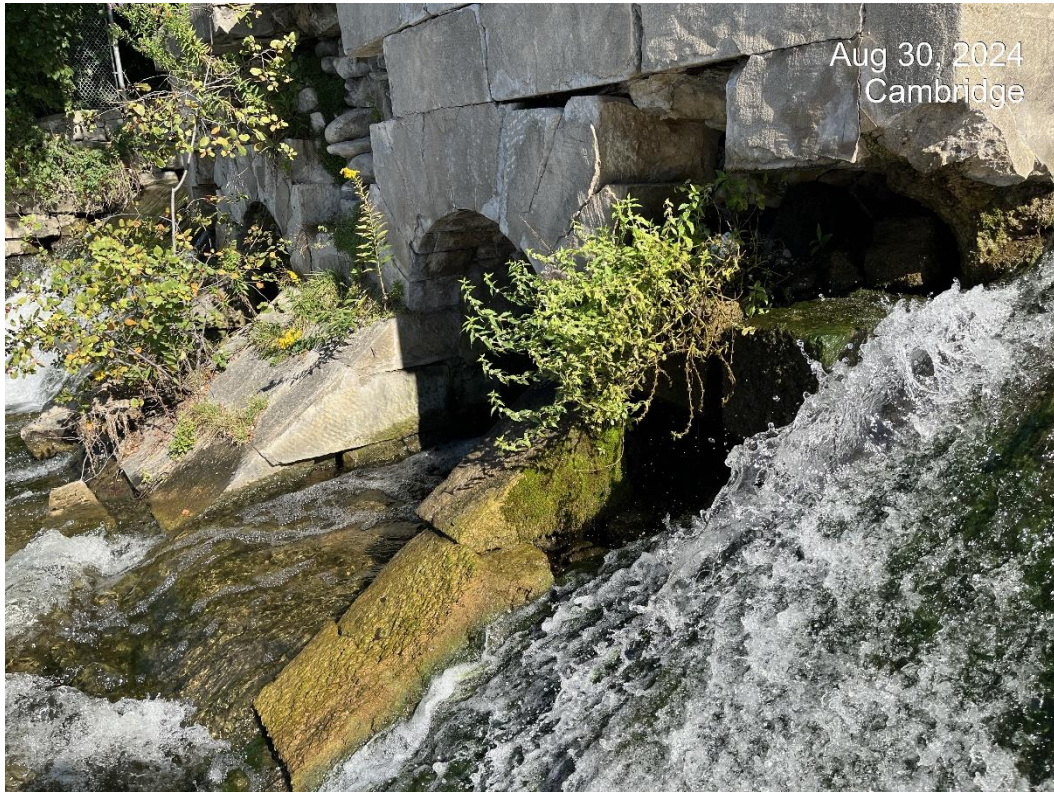
Photo 3 – South End of North Stop Log Structure

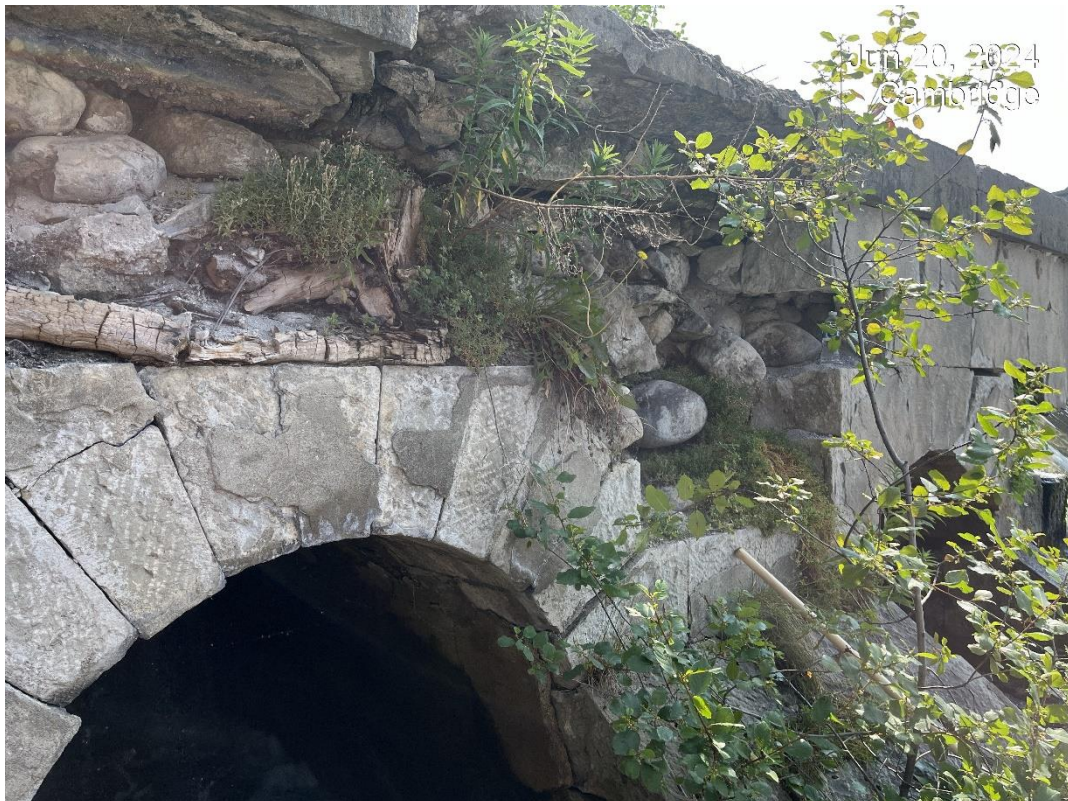
Photo 4 – Face of North Stop Log Structure

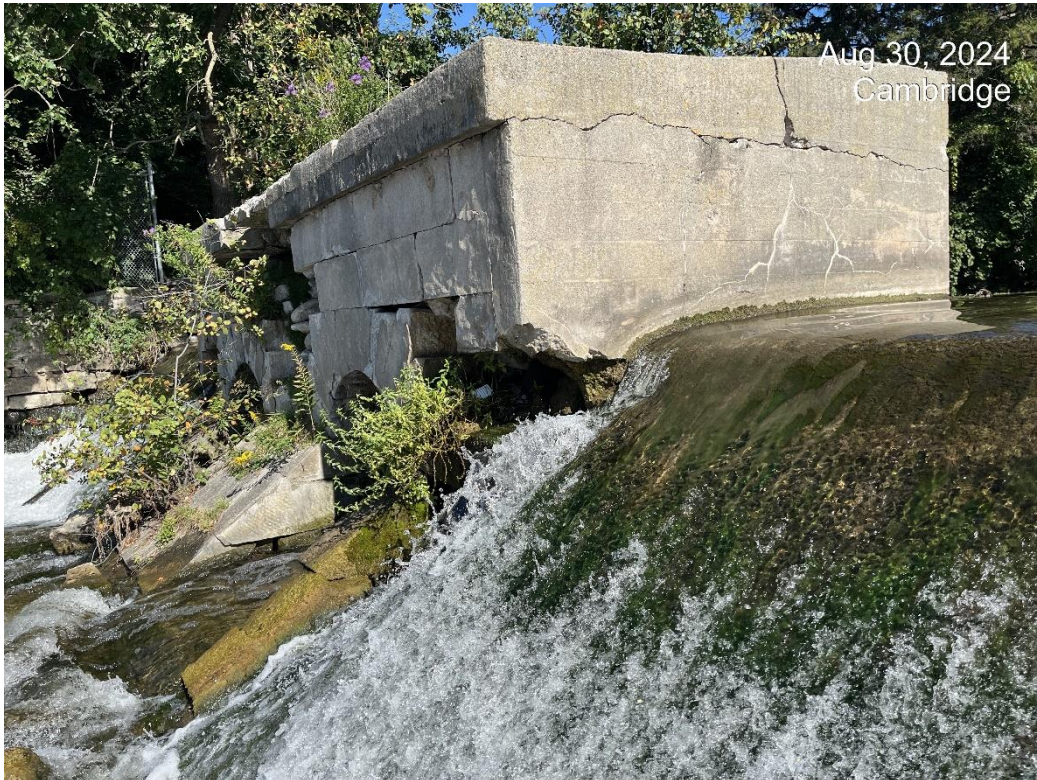
The top slab of the structure is cracked in several locations.

Photo 5 – Cracking along Top of North Stop Log Structure

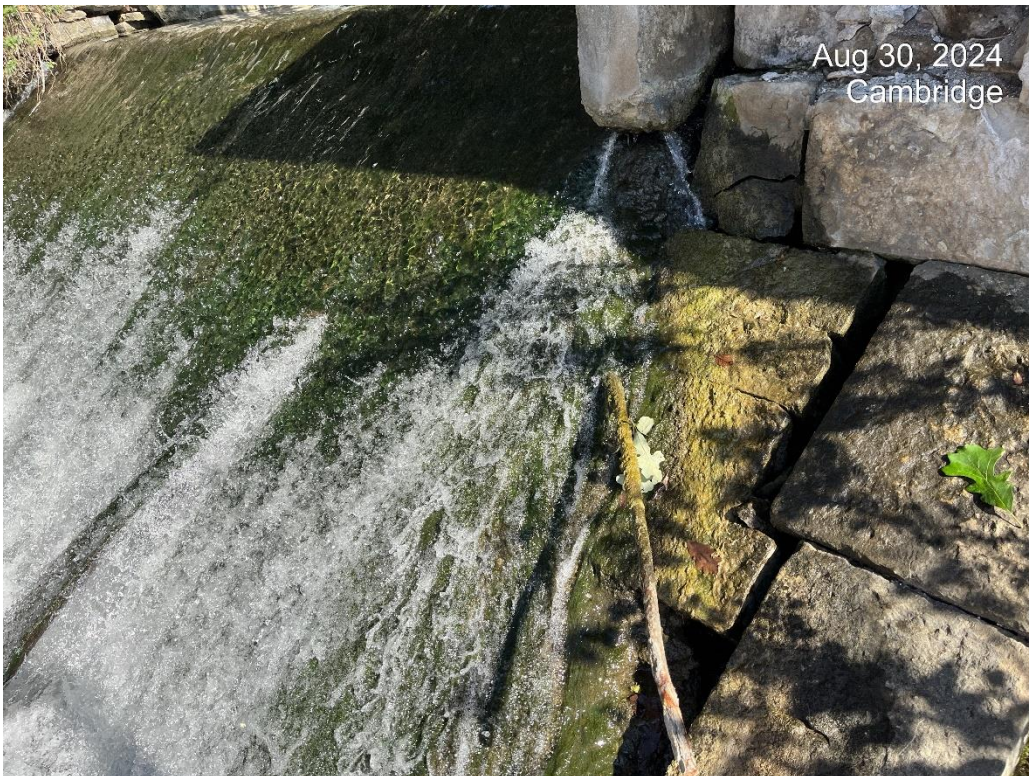
Photo 6 – Exposed Rebar at North End of North Stop Log Structure

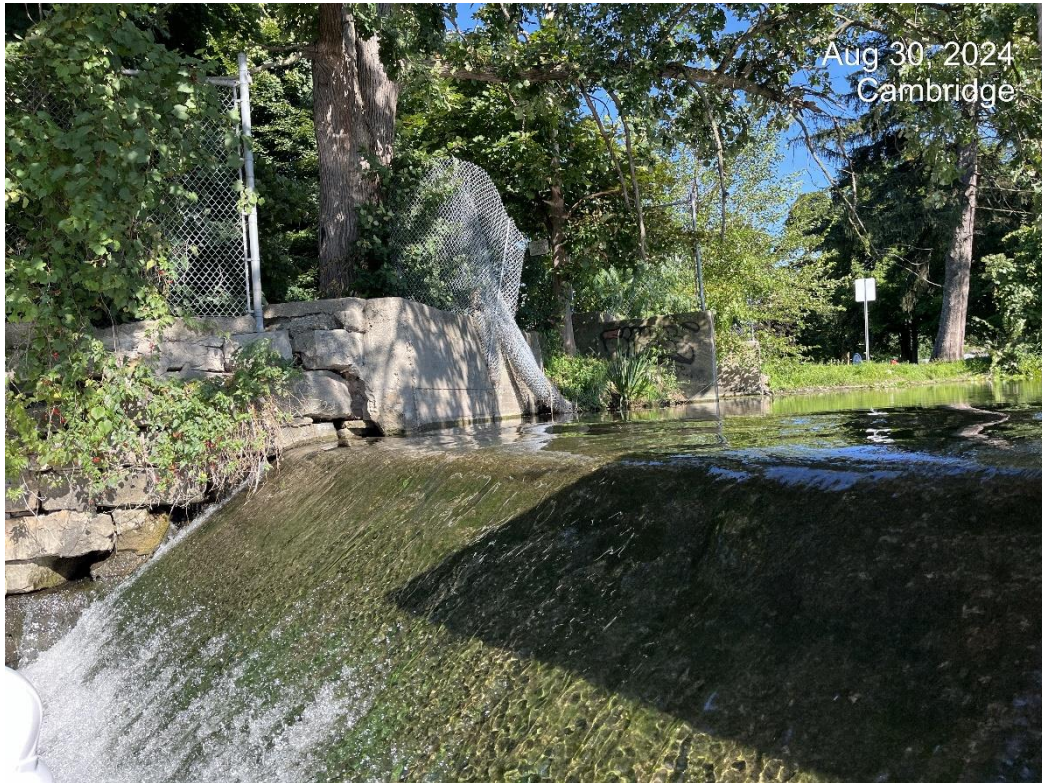
Photo 7 – North Spillway / Retaining Wall – Note Gaps in North Wall

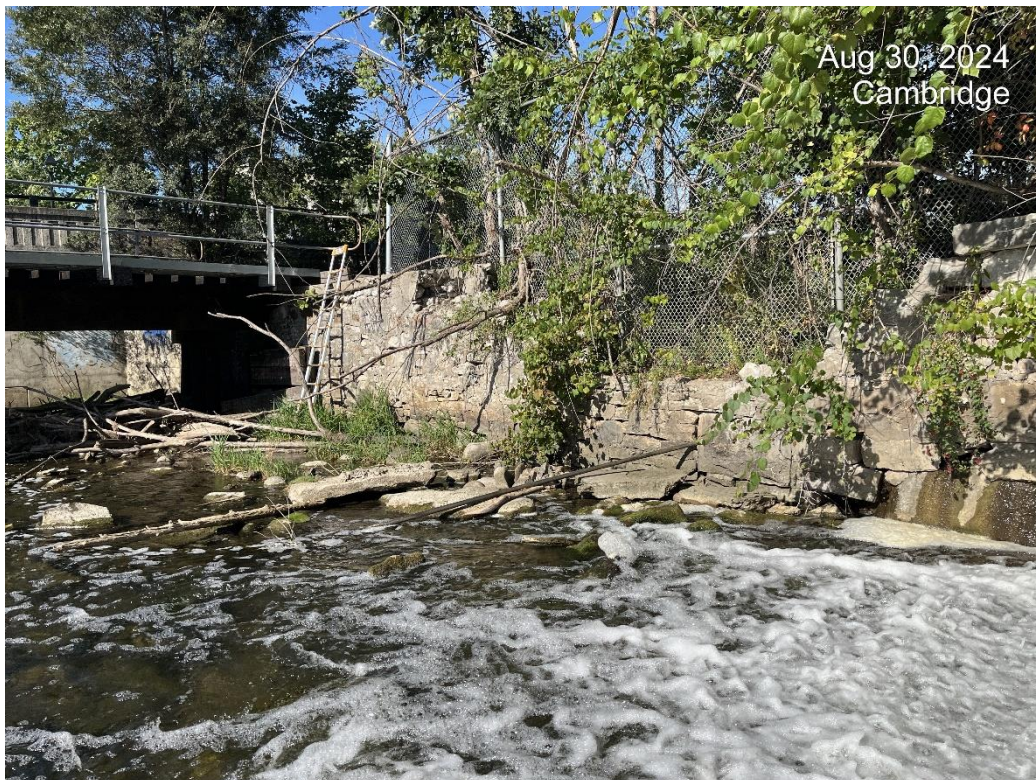
The retaining wall on the North side of the Speed River, just downstream from the dam is in poor condition. The footing structure is eroded, and the joints are open. Masonry blocks have popped out at several locations and concrete/mortar has eroded from the wall. Water was observed to be flowing behind the blocks.

Photo 8 – North Retaining Wall immediately Downstream of Spillway

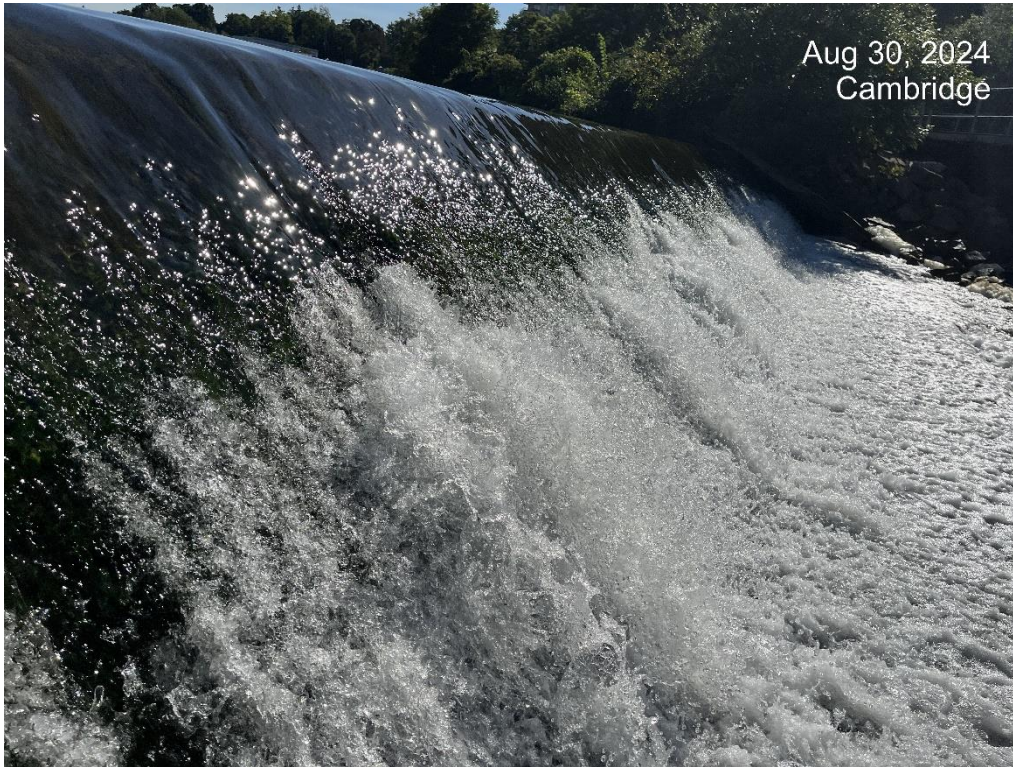
Photo 9 – Typical Condition of Spillway – Note White Water Presence due to Erosion/Spalling

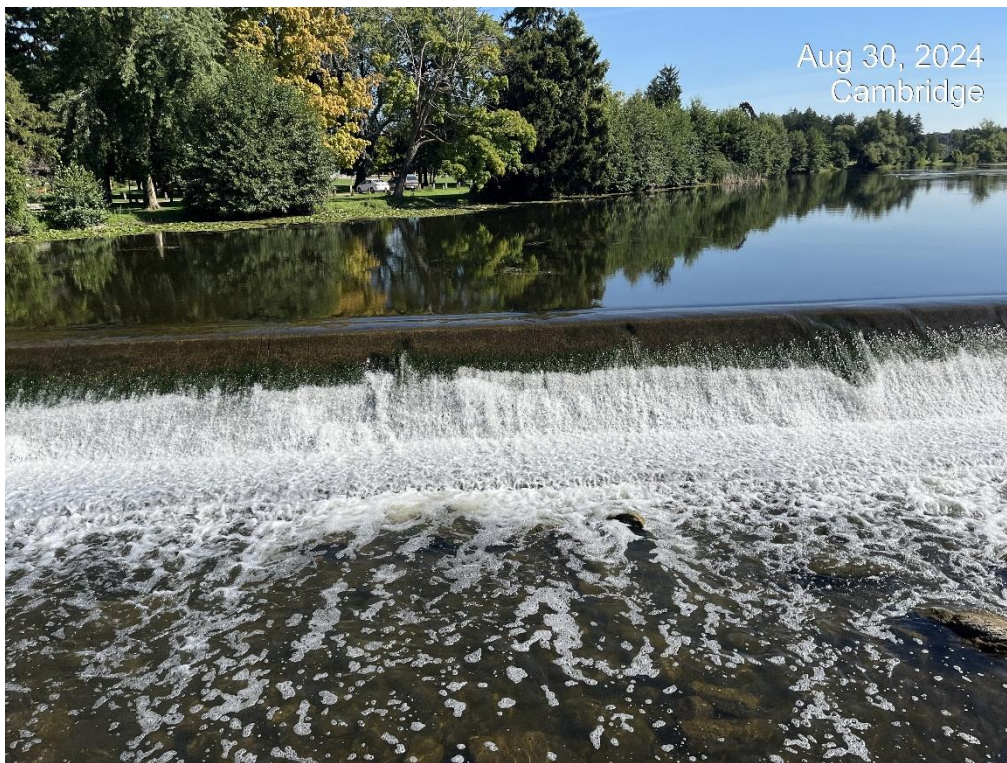
Photo 10 – Typical Condition of Spillway – Note White Water Presence due to Erosion/Spalling

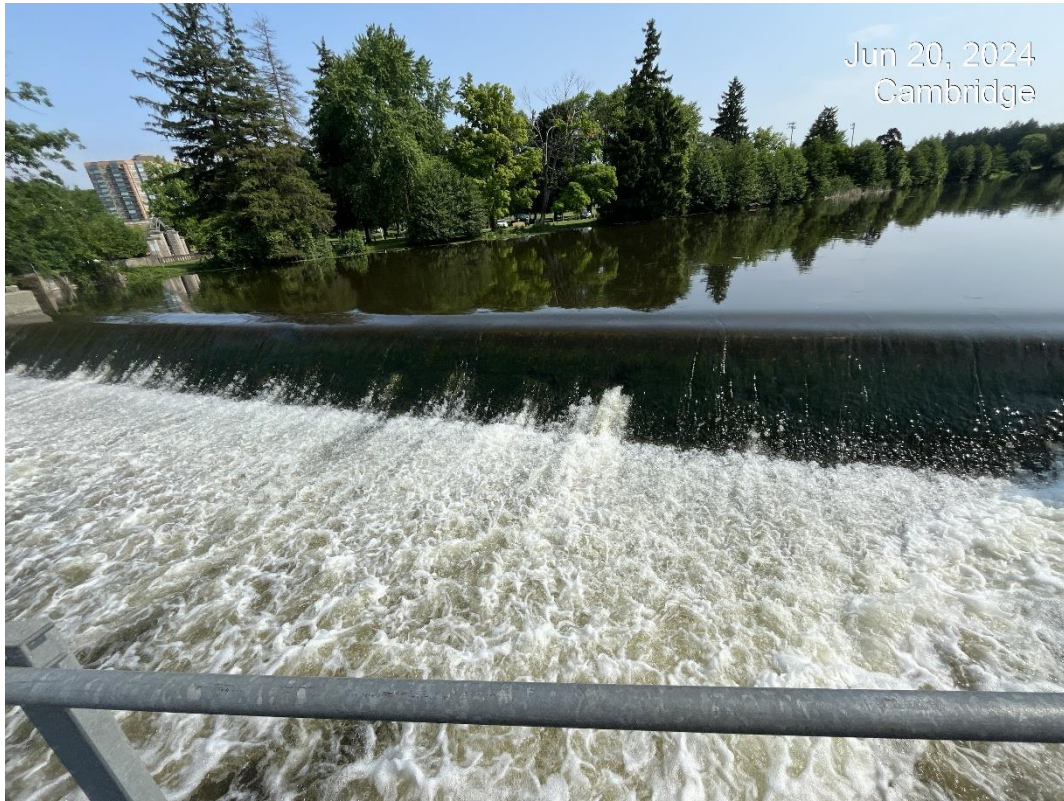
Photo 11 – Typical Condition of Spillway – Note White Water Presence due to Erosion/Spalling

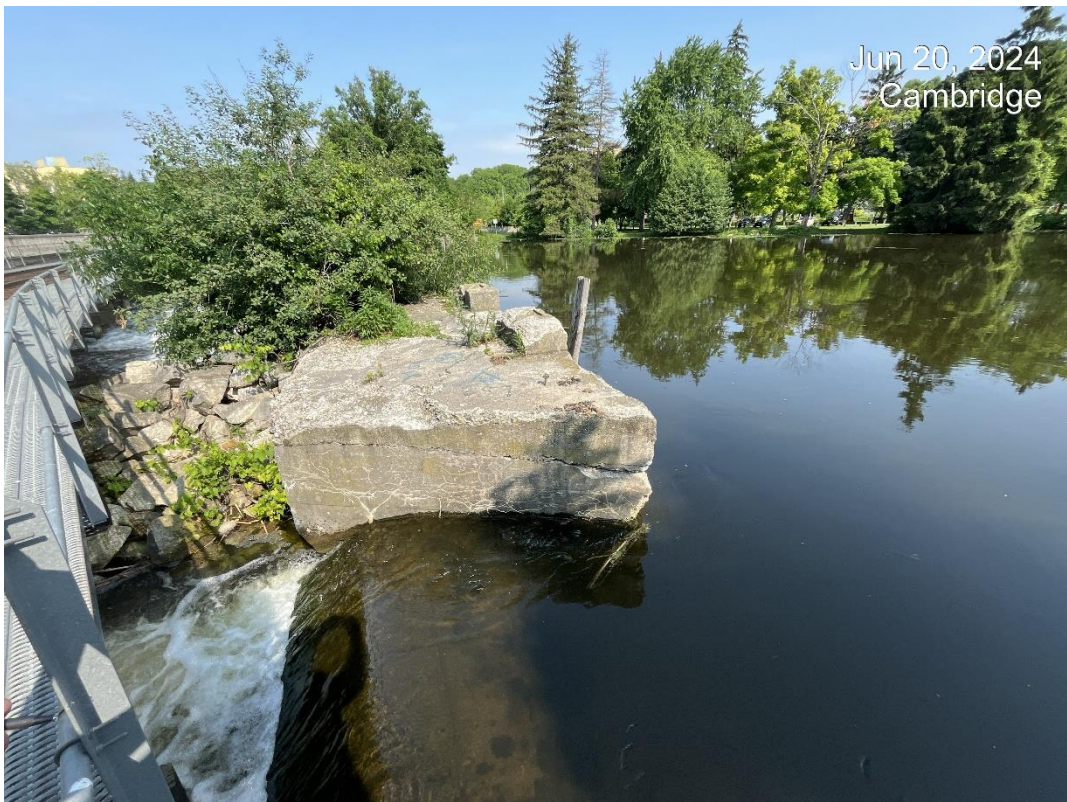
The south stop log structure is generally in poor condition, with cracks, spalling and disintegration observed on the top face of the structure. A wide horizontal crack was visible in the wall around most of the structure. Debris, especially trees and vegetation, has built up upstream of the stop log structure. To prevent collapse or sliding of the south stop log structure, rip rap was placed directly downstream of the structure and used to block the raceways. As a result, no water flows through the structure.

Photo 12 – South Stop Log Structure – South Side

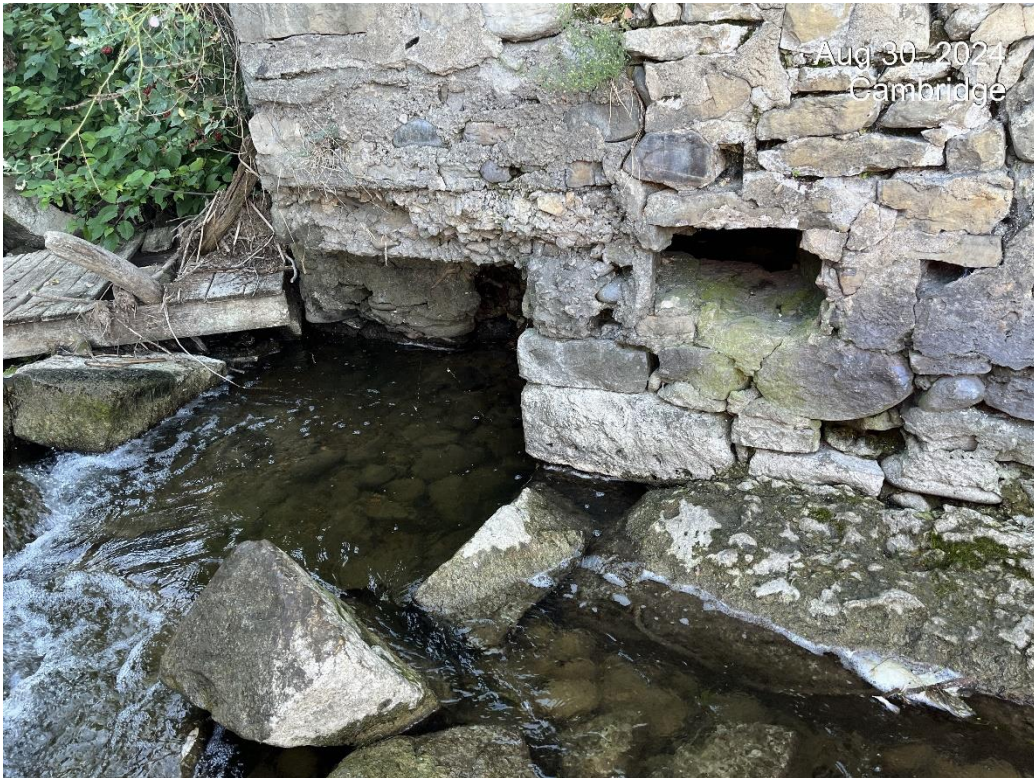
The retaining wall on the South side (Southeast of the rail bridge) was found to be in poor condition. Due to erosion of the footing structure and loss of masonry blocks, a substantial cavity has formed (see Photo 13) which yields the ground directly behind the wall unsuitable for any loading. Fortunately, the ground behind the retaining wall is an abandoned industrial site so there is no immediate risk, if this area is closed off. In addition to the cavity, several blocks are eroded, and joints have lost their mortar. Following recommendations from the previous inspection in 2022, the City installed several temporary concrete blocks on the ground above the noted cavity to prevent vehicles from parking or operating in this area.

Photo 13 – South Retaining Wall – Note Cavity

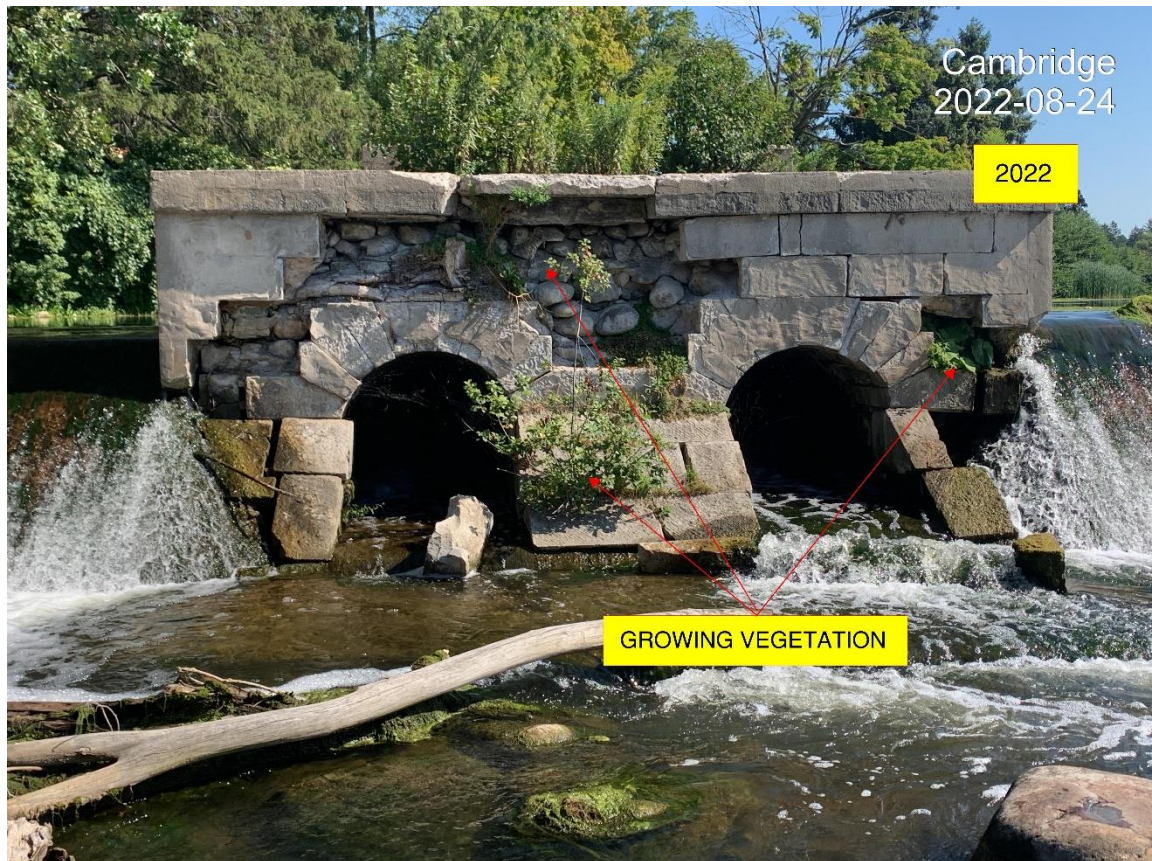
Photo 1 – North Stop Log Structure 2022

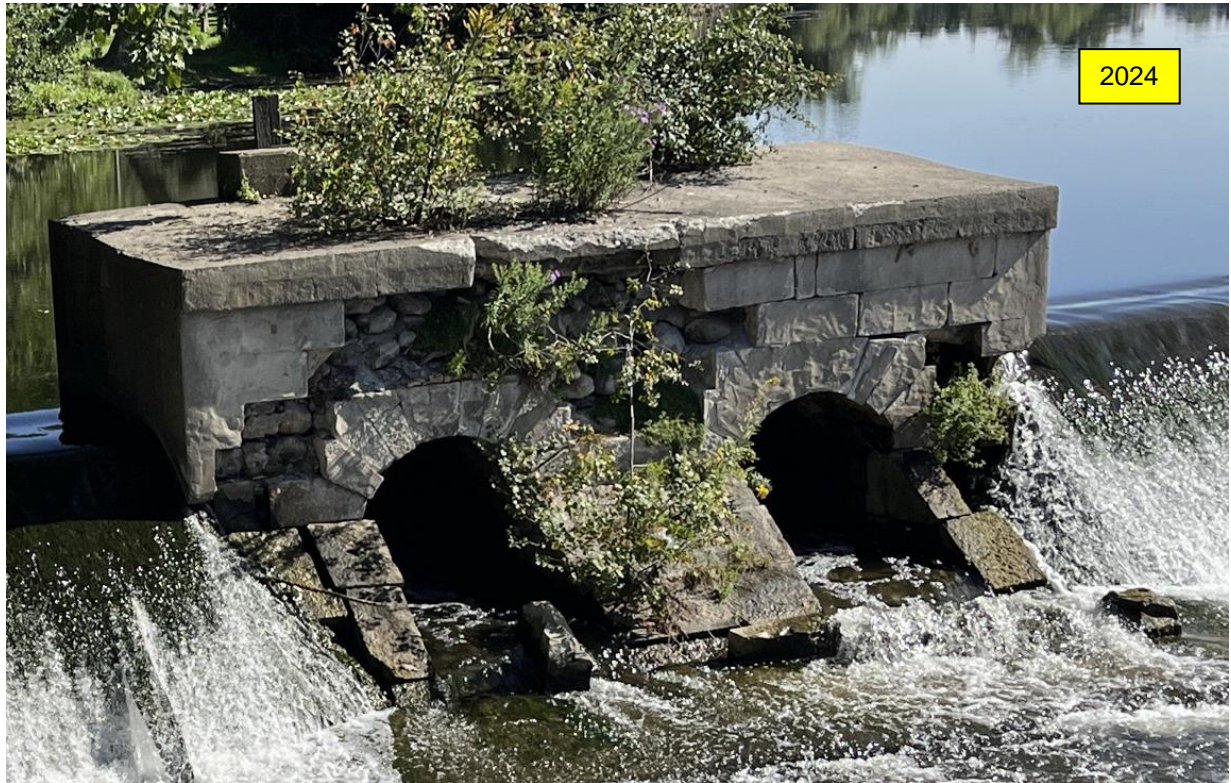
Photo 2 – North Stop Log Structure 2024
