Sheave Tower Structural Condition Assessment

90 Old Mill Road
Cambridge, Ontario

March 25, 2024

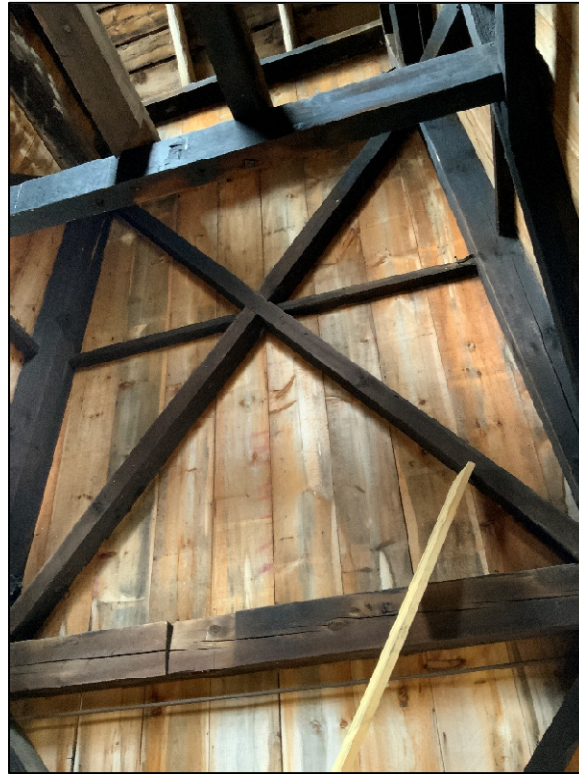
Photograph 1: Partial interior elevation

Corner columns and the primary crossing members were measured onsite as 8x8. Lapped diagonal braces were measured as 4x6, and the intermediate siding support members are 2x4. Several scarf joints were noted connecting upper and lower sections of the corner columns. The joints are connected with through-bolts and square headed nuts.

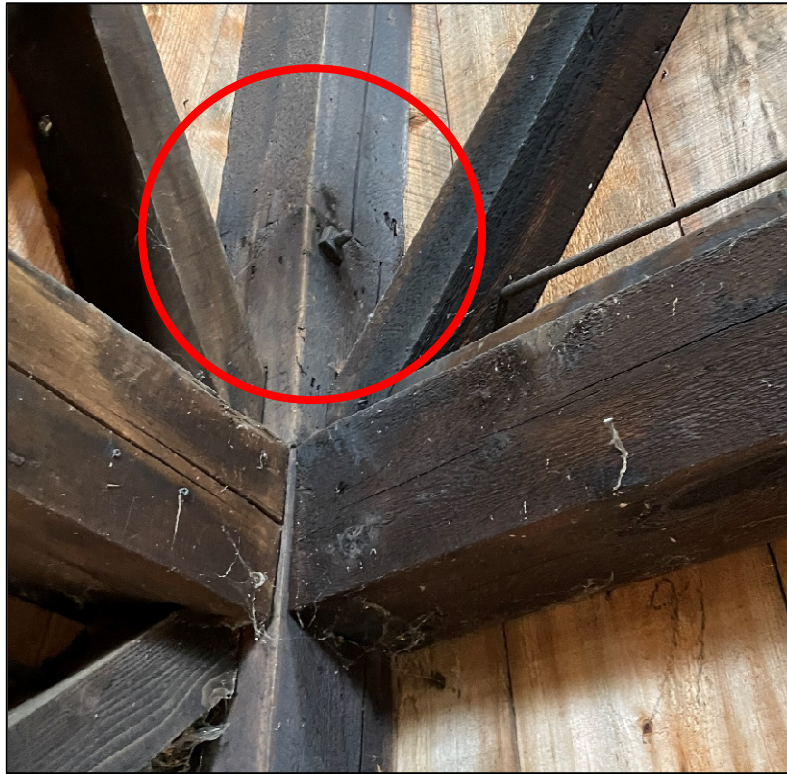
Photograph 2: Connection between upper and lower column sections

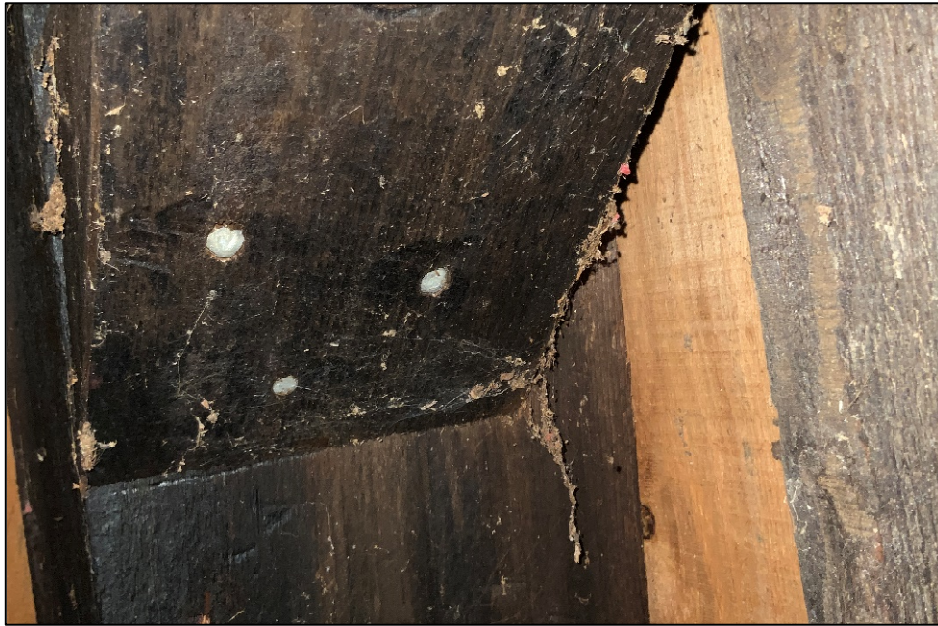
Diagonal braces were found in some locations to be secured to the vertical columns using round-headed galvanized nails, specifically where the diagonal braces come down in the middle of the height of the column. It is likely that these braces were altered or added as part of the lean-to addition work, although it cannot be confirmed that these nails were not added as part of some other maintenance or repair work. The specifics of the connections at the primary corners could not be determined at the time of the review.

Photograph 3: Connection of diagonal brace to column (south elevation)

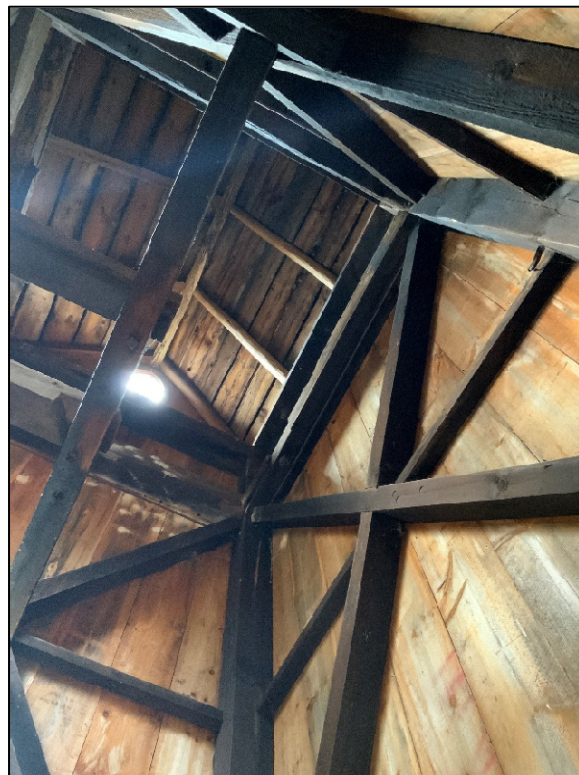
The upper roof is framed with a combination of round and milled timber rafters supported on an undressed log ridge beam and eave beams that appear to have been salvaged from another structure.

Photograph 4: Upper roof framing

2. Review the conditions of the roofing and flashing, and ensure that roofing maintenance and replacement is completed prior to a significant failure of the roof.

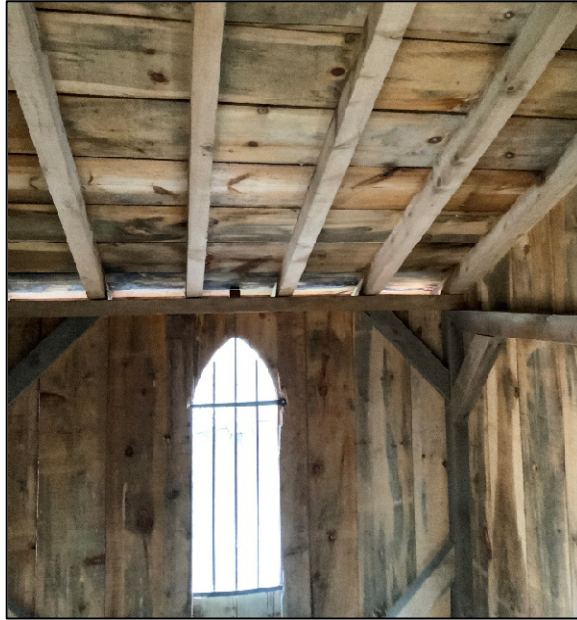
The south elevation lean-to is constructed with light braced frame walls and 3x4 wood rafters spaced at 16-18" on centre, all of which appear to have been part of the 1999 restoration program. It has been reported that this lean-to was added prior to 1962 to house a more modern means of electrical generation.

Photograph 5: Lean-to framing (typical)

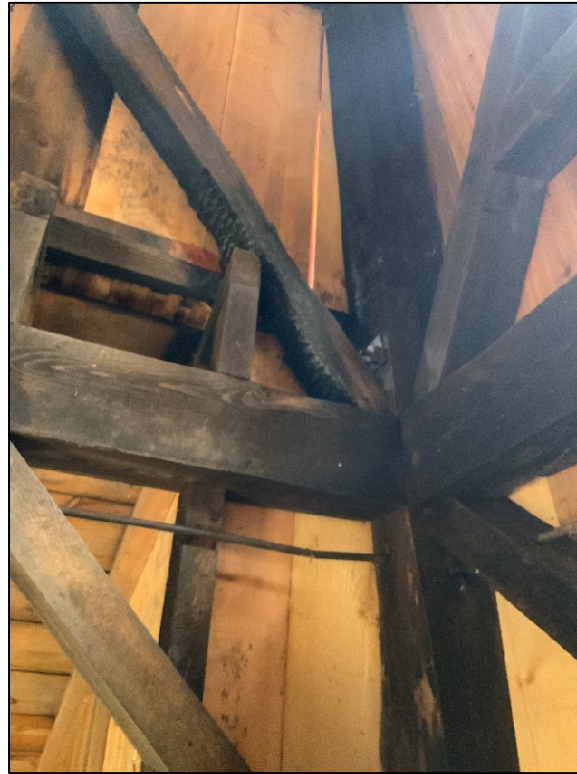
Localized charring damage was noted at the southwest corner approximately 9'-0" above the interior finished floor.

Photograph 6: Charring damage

This damage is reported to be the result of a minor fire within the last 24 months. The damage is limited to the base of a diagonal 4x6 brace and less substantial damage to the column above the horizontal crossing member. This damage has not significantly compromised the structural framing.

5. Consider the provision of lighting and/or other security measures to mitigate risk of vandalism and arson.
6. Carry out regular reviews of the exterior exposed concrete foundation walls, specifically at the northwest corner where the rougher exterior surface can result in accelerated freeze-thaw deterioration. These reviews can be completed at the same time as the regular monitoring of the property. Table 1 (below) includes a budget allowance for surficial concrete repairs to be completed in 2029, if required.

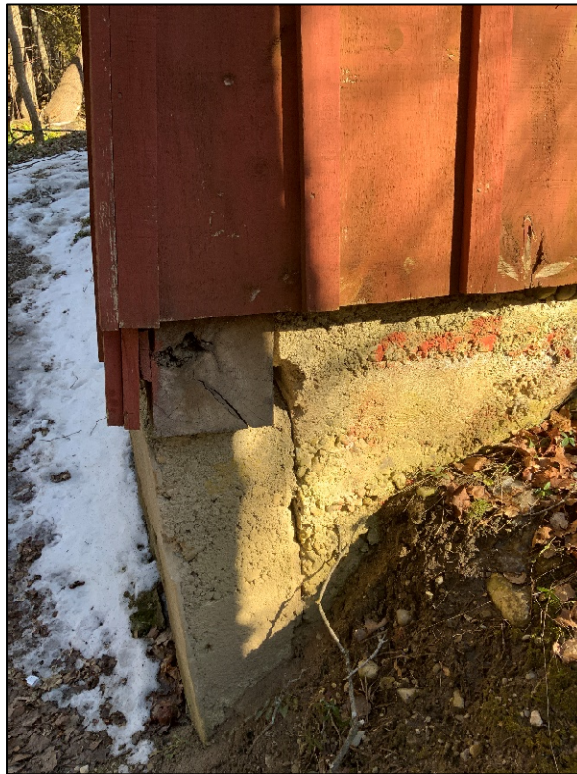
The foundation walls below the main building are in fair condition. The majority of the foundations are below grade and below the main floor structure, and as such were not visible for a detailed review. Where exposed at the northwest corner, at the lower grade, the concrete is honeycombed and an open vertical joint is visible at the corner.

Photograph 7: Exposed foundation wall at northwest corner

- Continue to monitor the property regularly and limit access to the interior.
- Carry out regular reviews of the exterior exposed concrete foundation walls, specifically at the northwest corner where the rougher exterior surface can result in accelerated freeze-thaw deterioration. These reviews can be completed at the same time as the regular monitoring of the property.

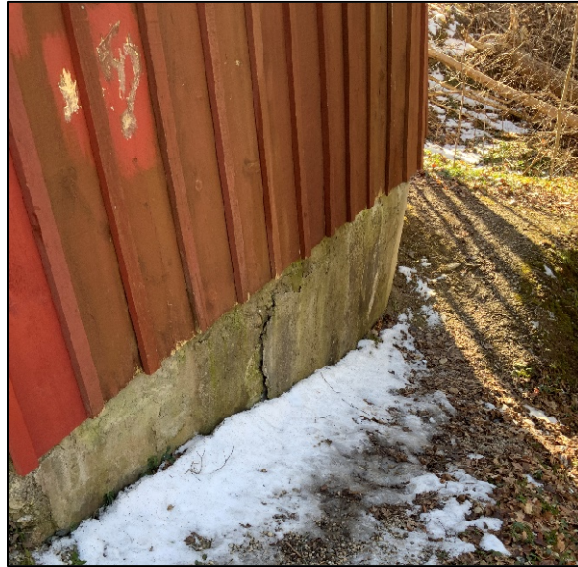
The exposed north elevation is in fair condition and showing signs of spalling. This spalling material appears to be a thin parge not part of the original construction.

Photograph 8: North foundation wall

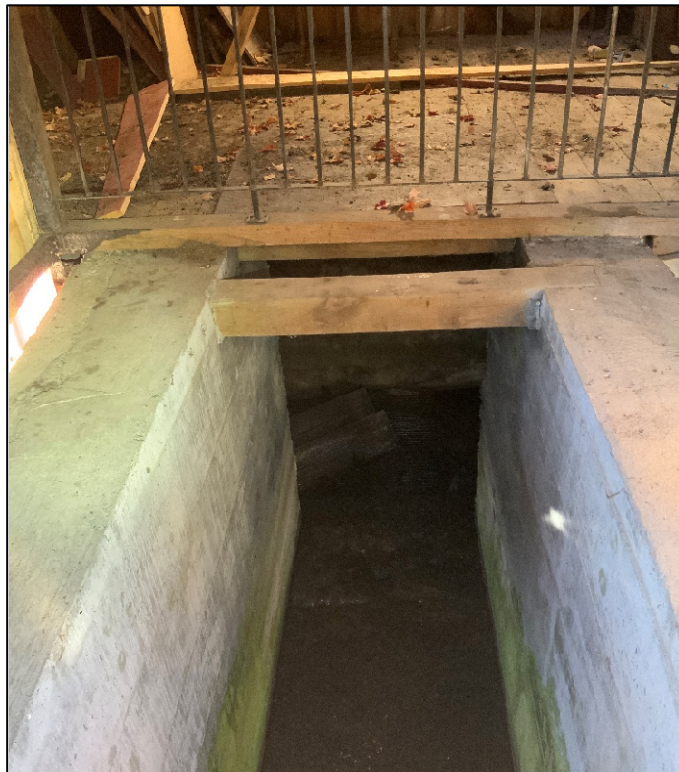
The foundation walls at the water intake are in good condition. The surface profile of the exposed concrete differs from that visible on the exterior of the building; it is likely that new concrete was added at some point in the life of the structure.

Photograph 9: Water intake foundation walls

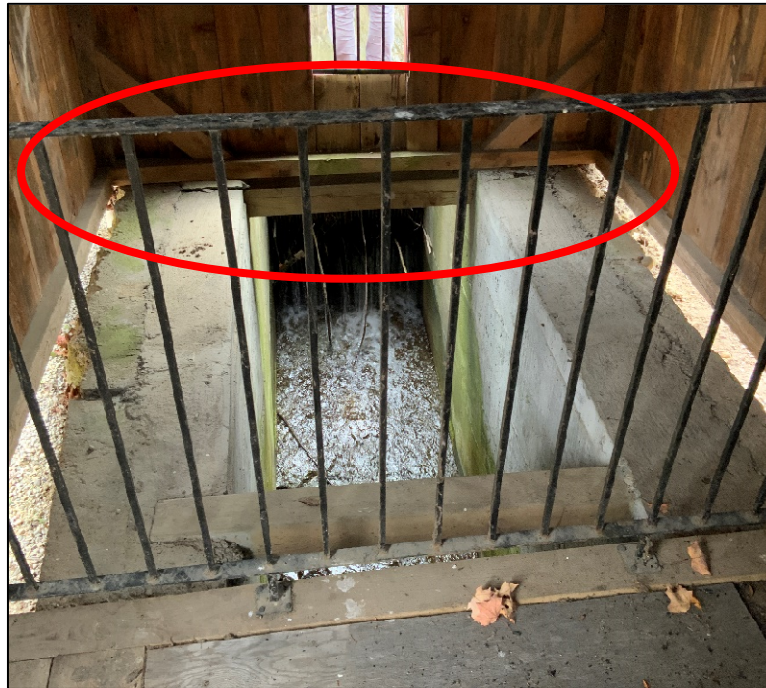
Wood crossing member have been cast into the tops of the wall, likely when the walls were repaired. The member below the endwall of the lean-to has contributed to cracking and spalling of the top of the wall. A cold joint is also visible from the interior of the building (refer to following photograph).

Photograph 10: Spalling concrete at cast-in wood
