CITY OF CAMBRIDGE

STRUCTURAL INSPECTION OF RIVERSIDE DAM INSPECTION REPORT - FINAL

NOVEMBER 11, 2022

PROJECT NO.: IM22108048.
DATE: NOVEMBER 11, 2022

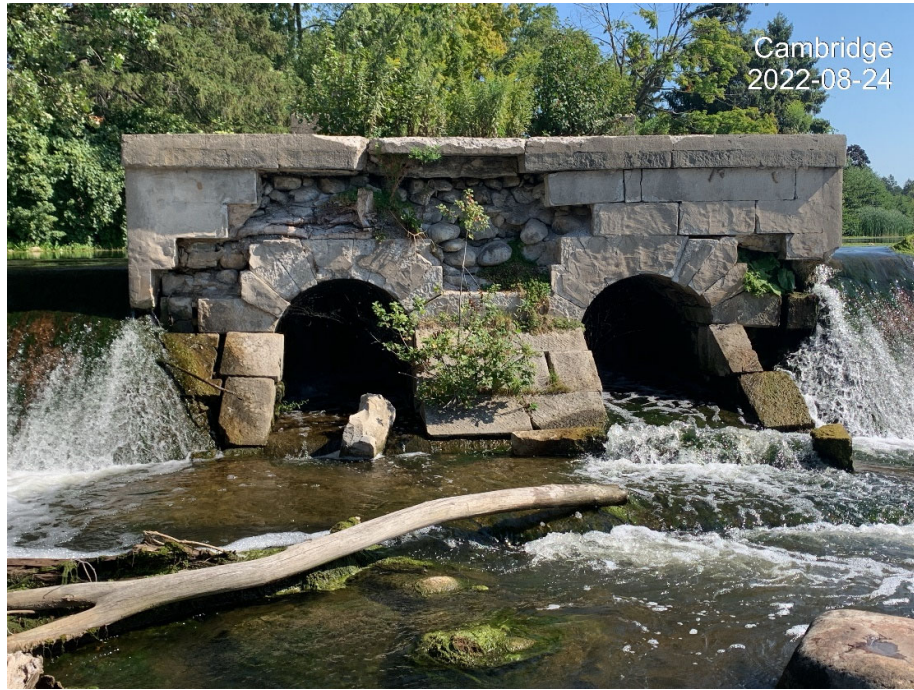
The north stop log structure is a masonry structure with significant sections of the front face missing. The exposed core consists of varying sizes of boulder rocks with a low strength cement mortar. The joints have opened up, and vegetation is growing through the open joints. Several large masonry blocks from the fascia are missing, and others are on the verge of falling off the structure. Appendix B identifies locations where progression of deterioration on the stop log structure were observed since the 2018 inspection.

The timber stop logs are closed; however, they are leaking (Refer to Photo 2), resulting in a small flow of water through the raceways. This is typical at both raceways (arches shown in Photo 1) on the North structure. The wooden stop logs appear to be in poor condition.

Photo 1 - Elevation View of North Stop Log Structure

1. The debris buildup throughout the dam should be removed as soon as possible. This includes the buildup around the north and south stop log structures, and the scattered debris jammed on the spillway.
2. For the North Stop Log Structure, it is recommended that the raceways be blocked up as was previously done for the South Stop Log Structure as failure of the stop log structure would compromise the integrity of the dam. The details of this work would need to be determined through a separate design assignment. Two (2) options that are possible are:
 - a. Install large riprap inside the raceways and in front of the structure, like what was done at the South Stop Log Structure.
 - b. Completely fill the raceways with grout. (Some riprap could also be installed in the front of the structure).

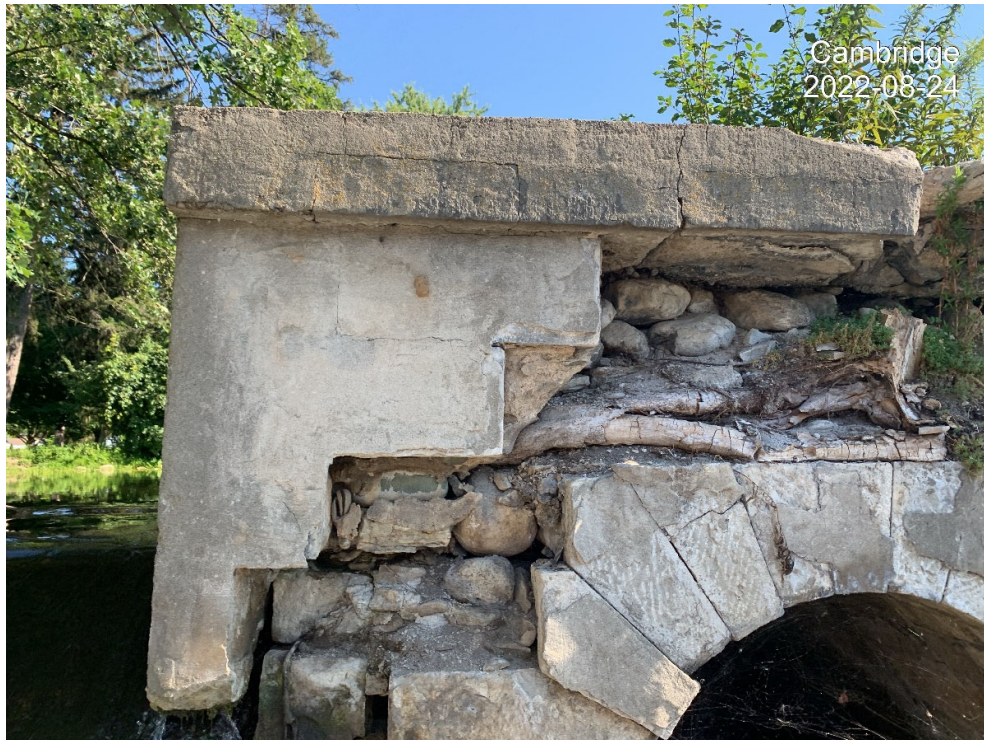
Photo 2 - Top Left Corner of North Stop Log Structure

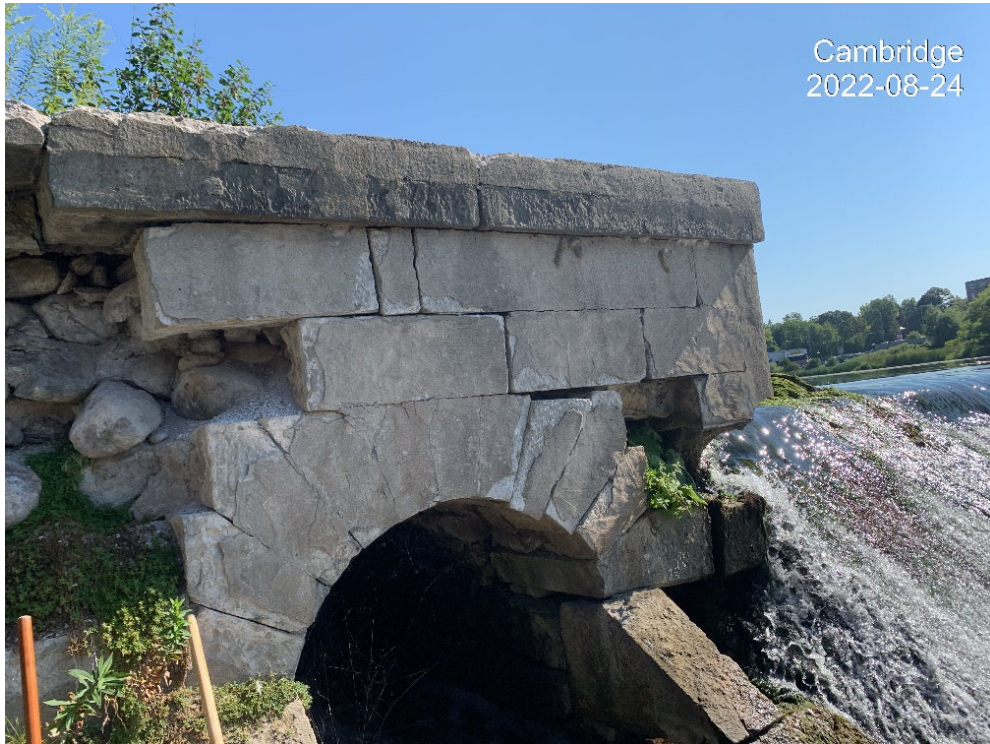
Photo 3 – Top Right Corner of North Stop Log Structure

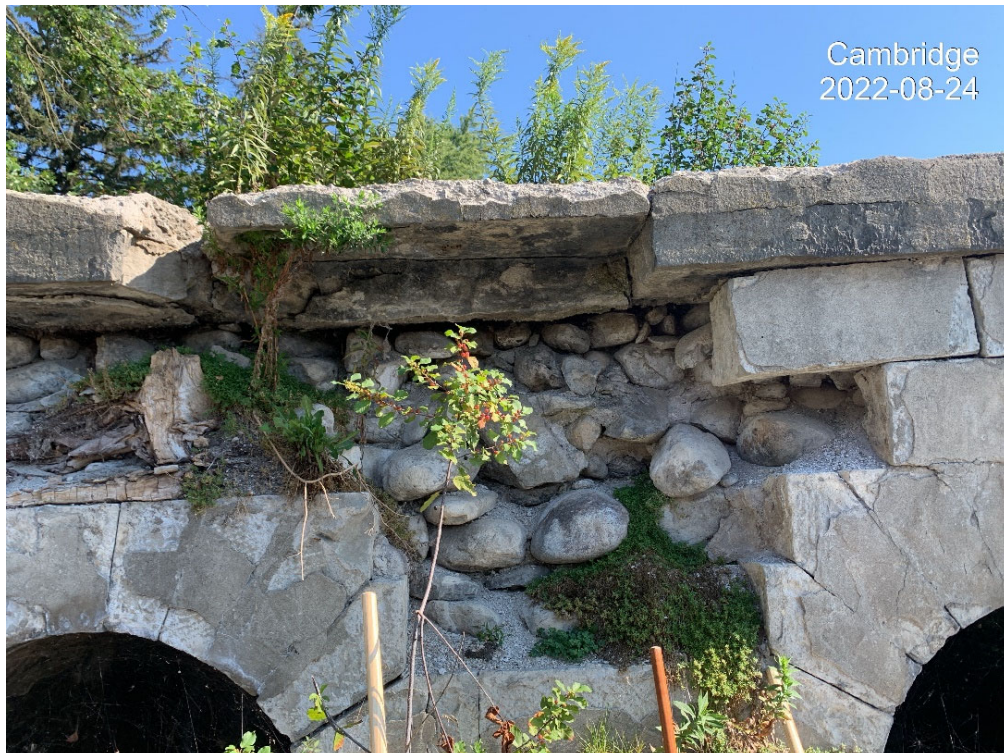
Photo 4 – Significant Exposure of Core of the North Stop Log Structure

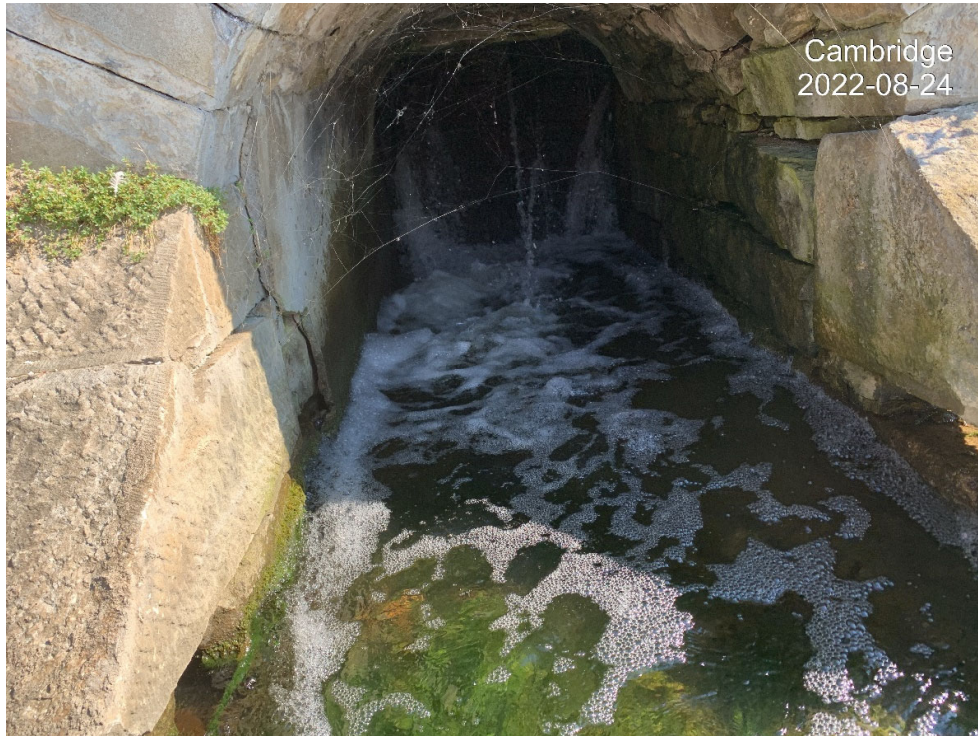
Photo 5 – Leaking Timber Stop Logs on Left Raceway of North Stop Log (Note the Exposed Masonry Blocks)

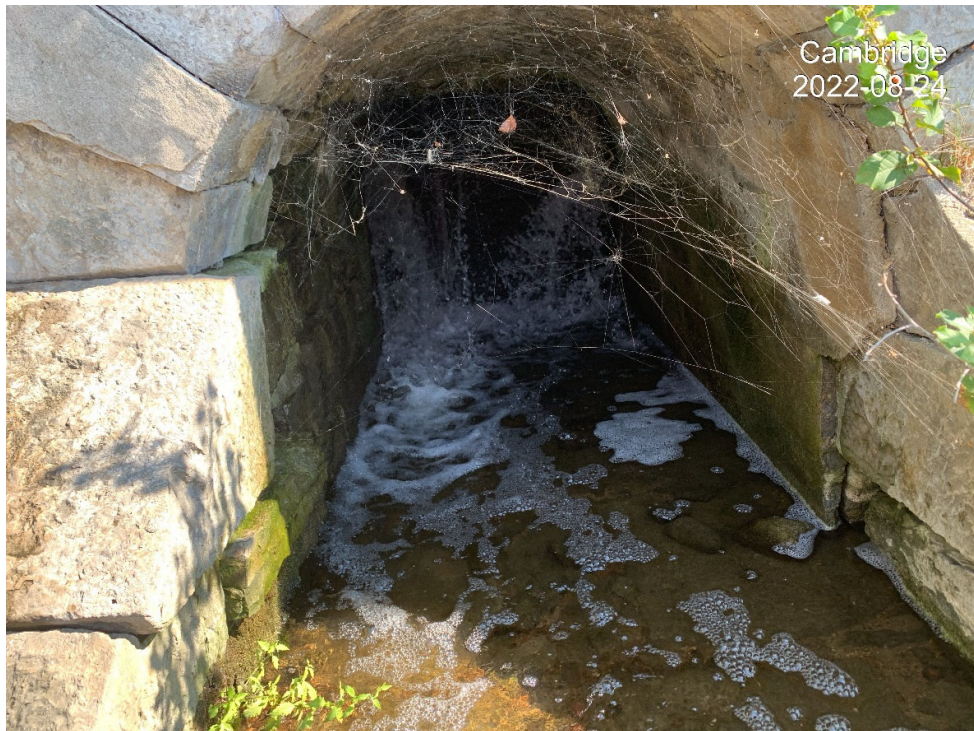
Photo 6 - Leaking Timber Stop Logs on Right Raceway of North Stop Log (Note the Exposed Masonry Blocks)

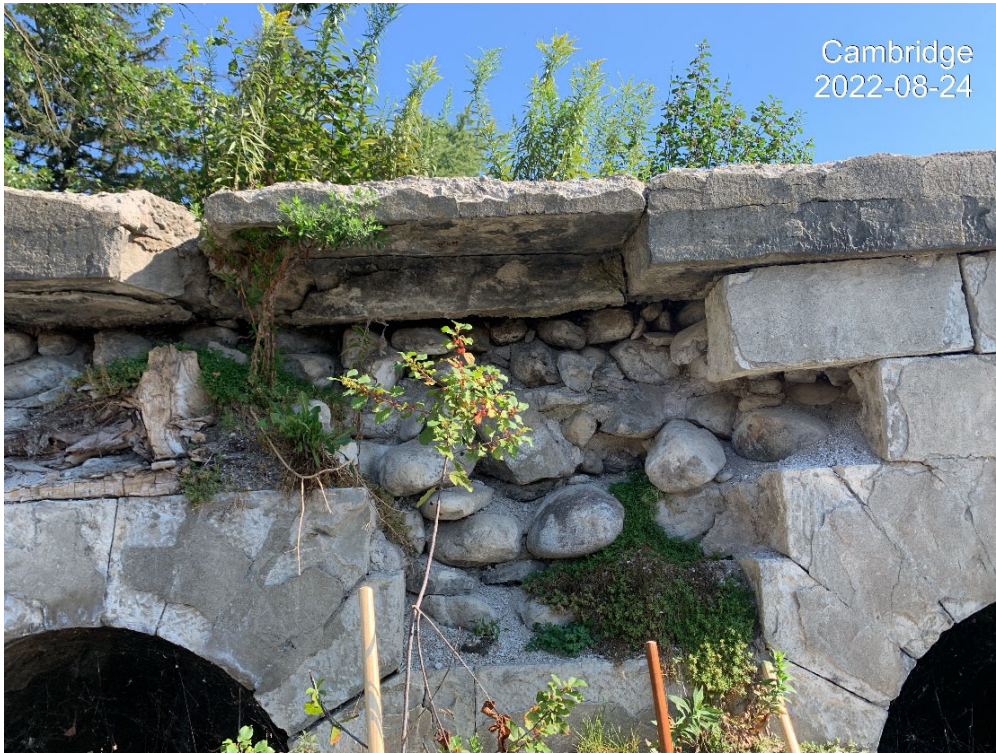
Photo 7 – Vegetation on North Stop Log Structure (1)

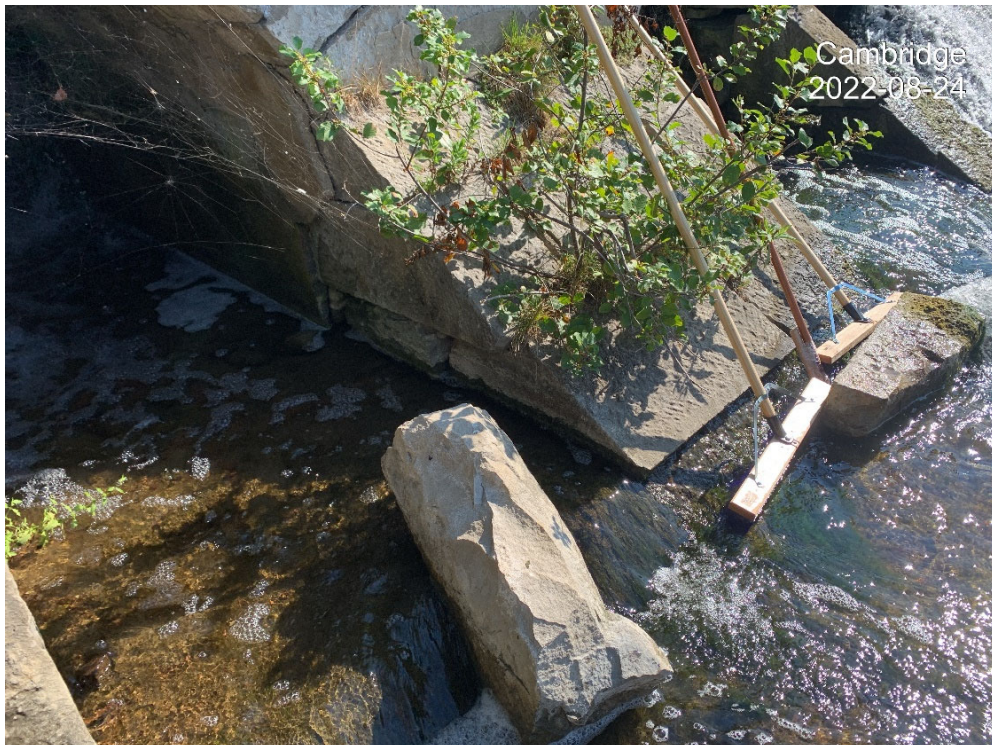
Photo 8 – Vegetation on North Stop Log Structure (2)

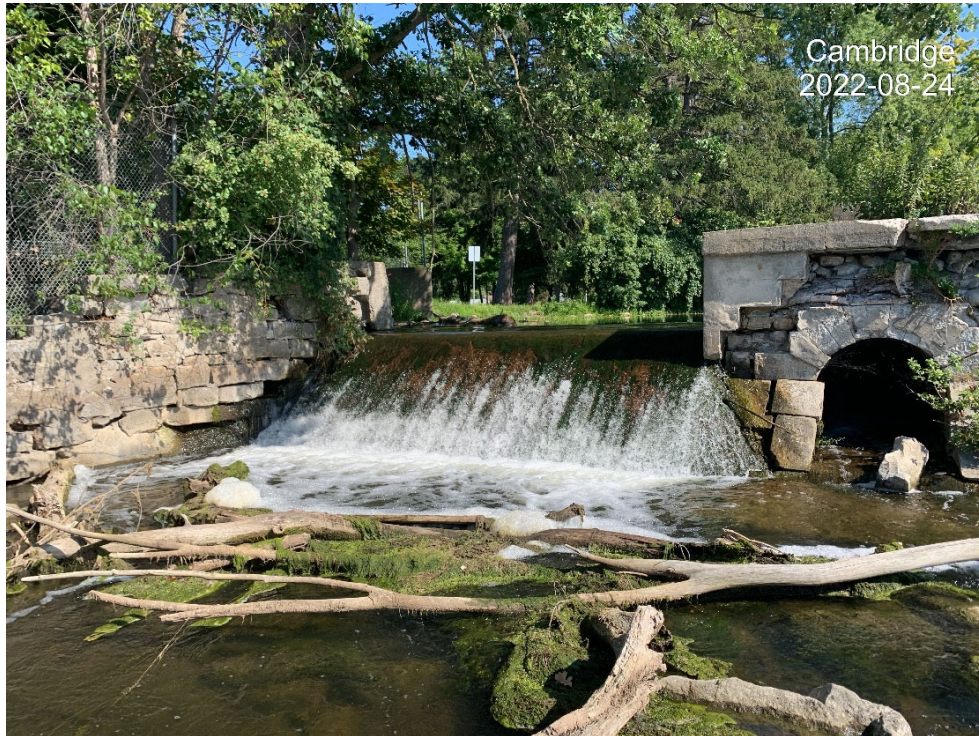
The retaining wall on the North side of the Speed River, just downstream from the dam is in poor condition. The footing structure is eroded, and the joints are open. Masonry blocks have popped out at several locations and concrete/mortar has eroded from the wall. Water was observed to be flowing behind the blocks.

Photo 9 – North Retaining Wall / Loss of Concrete Cover and Mortar - No noticeable change since 2018

1. For the North Retaining Wall Structure, it is recommended that the wall be repaired, and two possible options include:
 - a. For short-term repairs, a two-stage approach can be utilized comprising of first stabilizing the soil behind the wall with chemical grouting and second, forming and pumping grout at locations of voids on the face of the wall; and
 - b. For a long-term repair, a combination of soil anchors drilled through the wall and sprayed on shotcrete can be utilized.

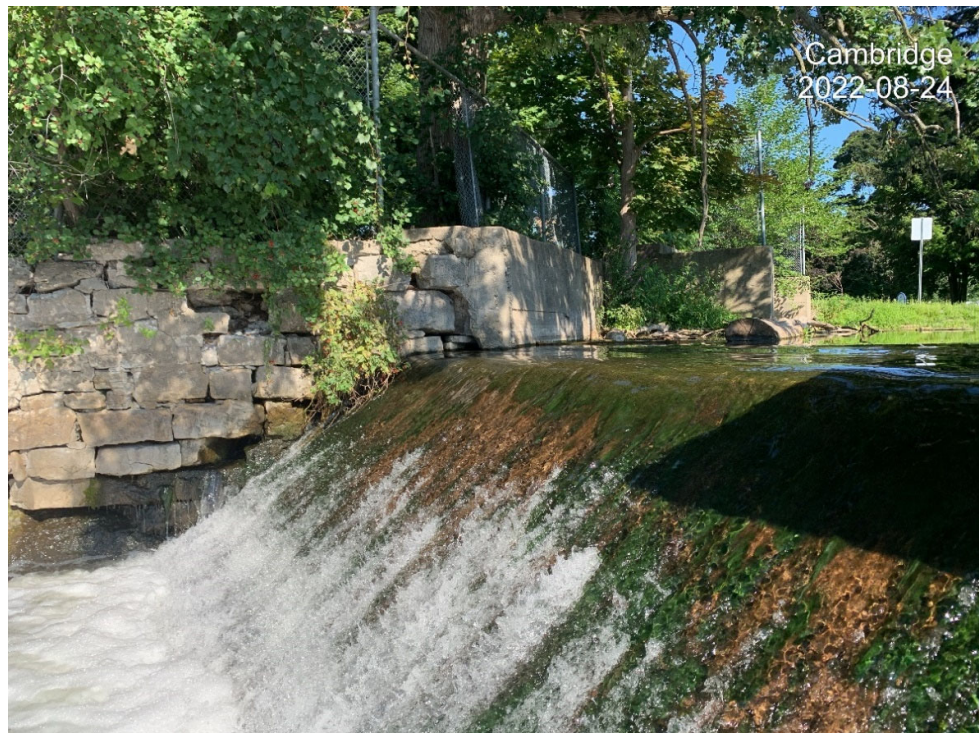
Photo 10 – Pop-out / Water Penetrating under Concrete Blocks

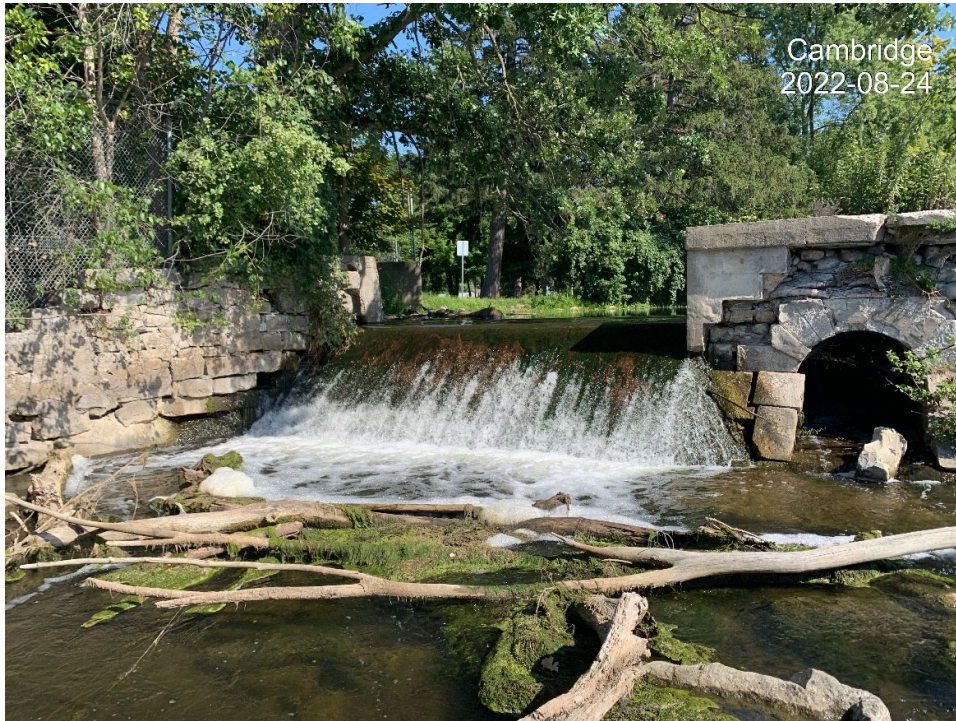
Erosion along the face of the spillway was observed. Within the white-water zones, the depth of concrete shell erosion typically ranged from 50 mm to a maximum of 100 mm (adjacent to the south stop log structure). Areas at the bottom of the dam wall and sections of the concrete apron nearest the wall (toe of the dam) have eroded, and three specific locations were noticed with erosion ranging from 75-150mm.

Photo 11 – North Spillway / Erosion along Front Face

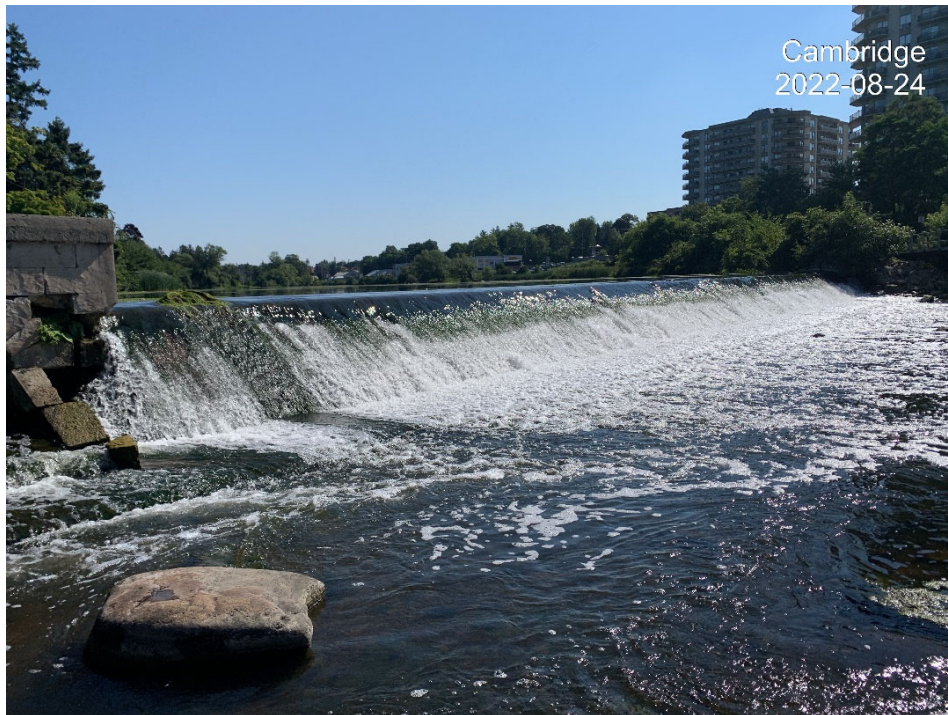
Photo 12 – Central Spillway / Erosion along Front Face

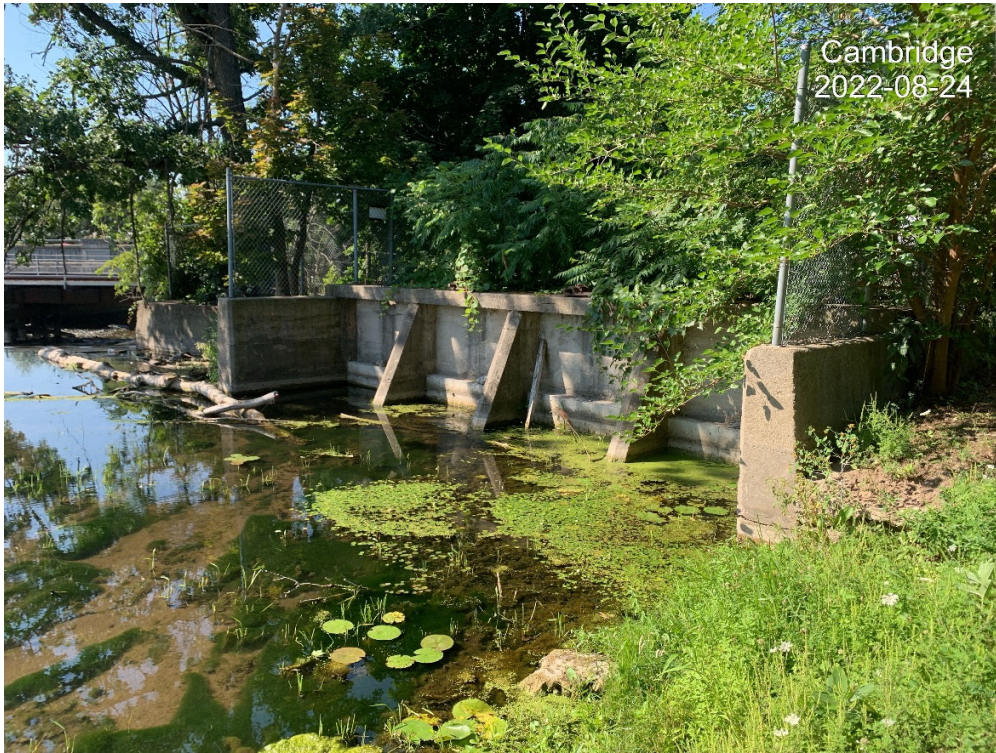
The sluiceway structure was inspected and found to be in good condition. Only a medium horizontal crack at the base of the north wall was observed. The north sluiceway is blocked up with rip rap and granular material, which prevents water from flowing through the structure.

Photo 13 – Sluiceway

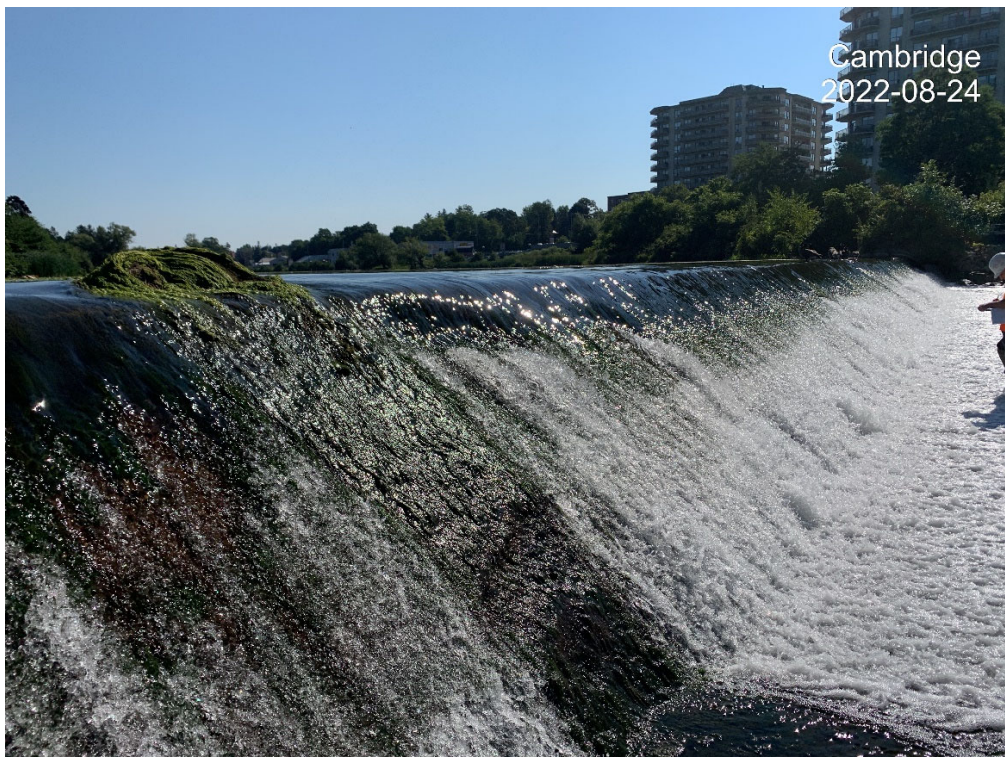
Photo 14 – Big Concrete Spall at the top

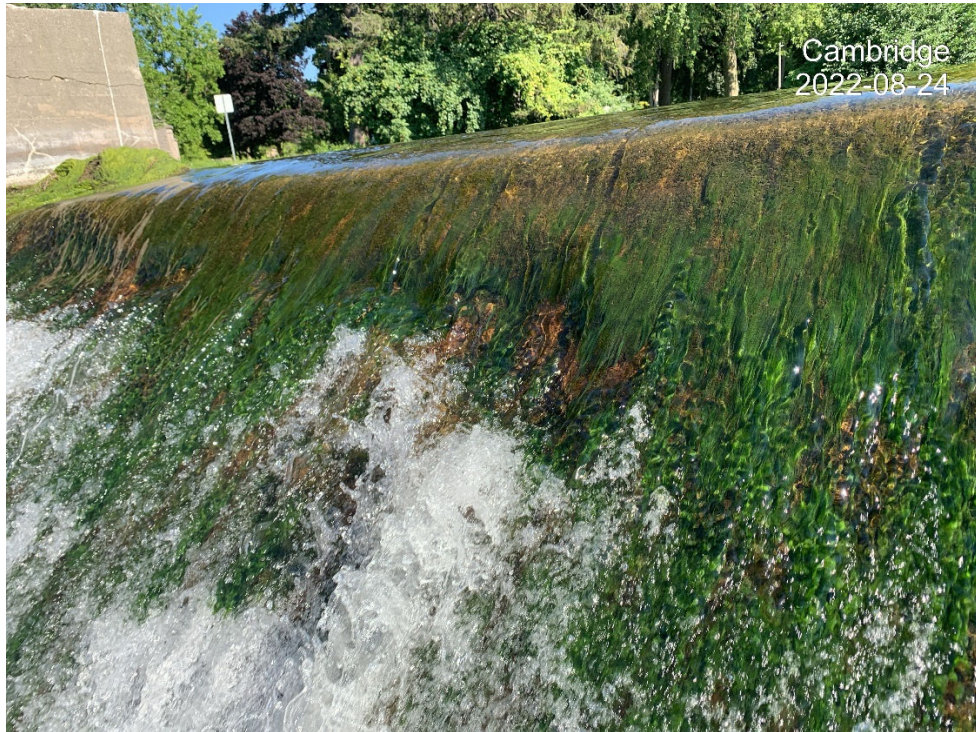
Photo 15 – Concrete Spall near the middle / Depressions

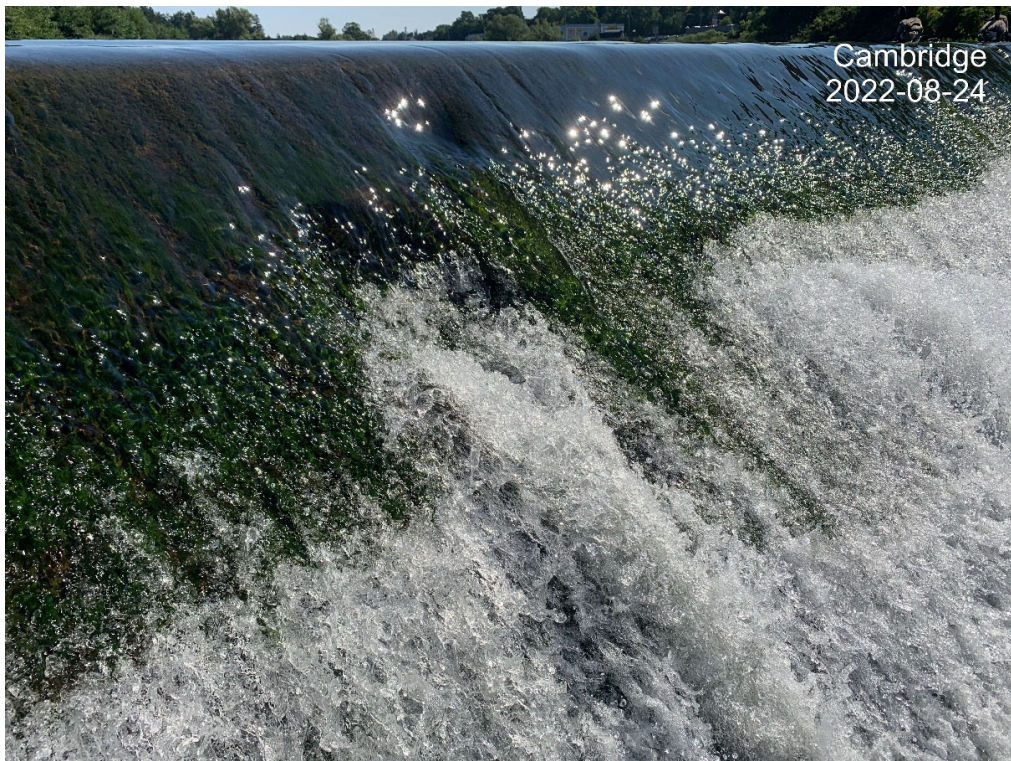
Photo 16 – Concrete Spall near the top and the middle

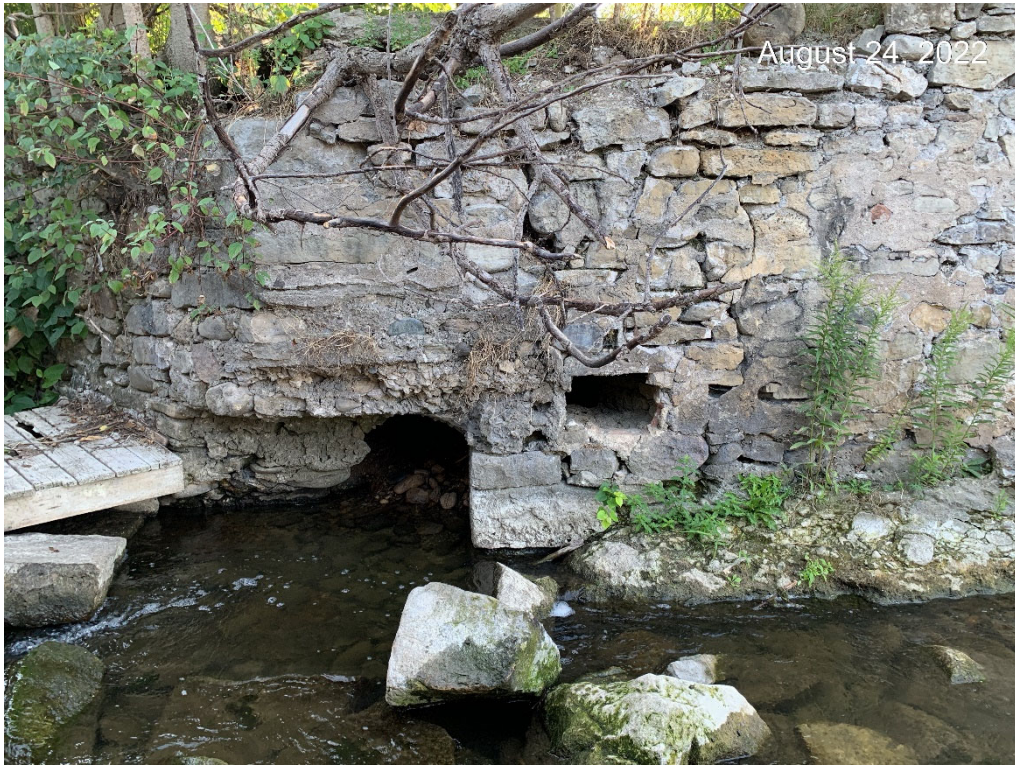
The retaining wall on the South side (Southeast of the rail bridge) was found to be in poor condition. Due to erosion of the footing structure and loss of masonry blocks, a substantial cavity has formed (see Photo 17) which yields the ground directly behind the wall unsuitable for any loading. Fortunately, the ground behind the retaining wall is an abandoned industrial site so there is no immediate risk, if this area is closed off. In addition to the cavity, several blocks are eroded, and joints have lost their mortar.

Photo 17 - Severe erosion and loss of material behind retaining wall

1. For the South Retaining Wall Structure, it is recommended that the abandoned industrial site directly behind the wall be blocked off with barriers to prevent accidental vehicle or pedestrian loading. The barriers should be placed at a minimum 10m radius from the front face of the wall. As mentioned in Section 3, due to the formation of the cavity, the ground above has lost most, if not all its capacity to carry any heavy loads.

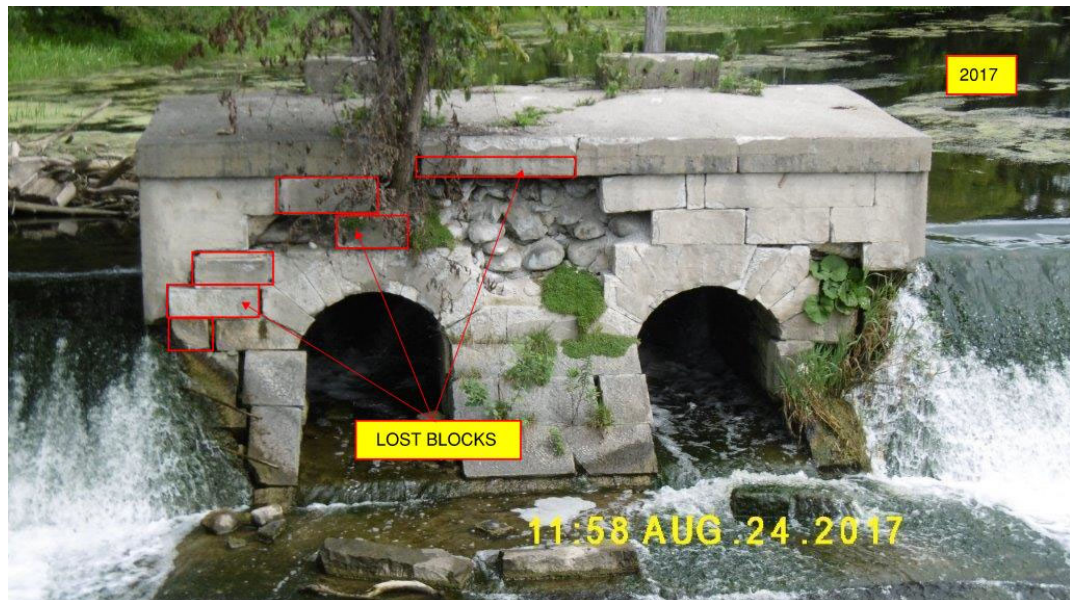
Photo 1 – North Stop Log Structure 2017

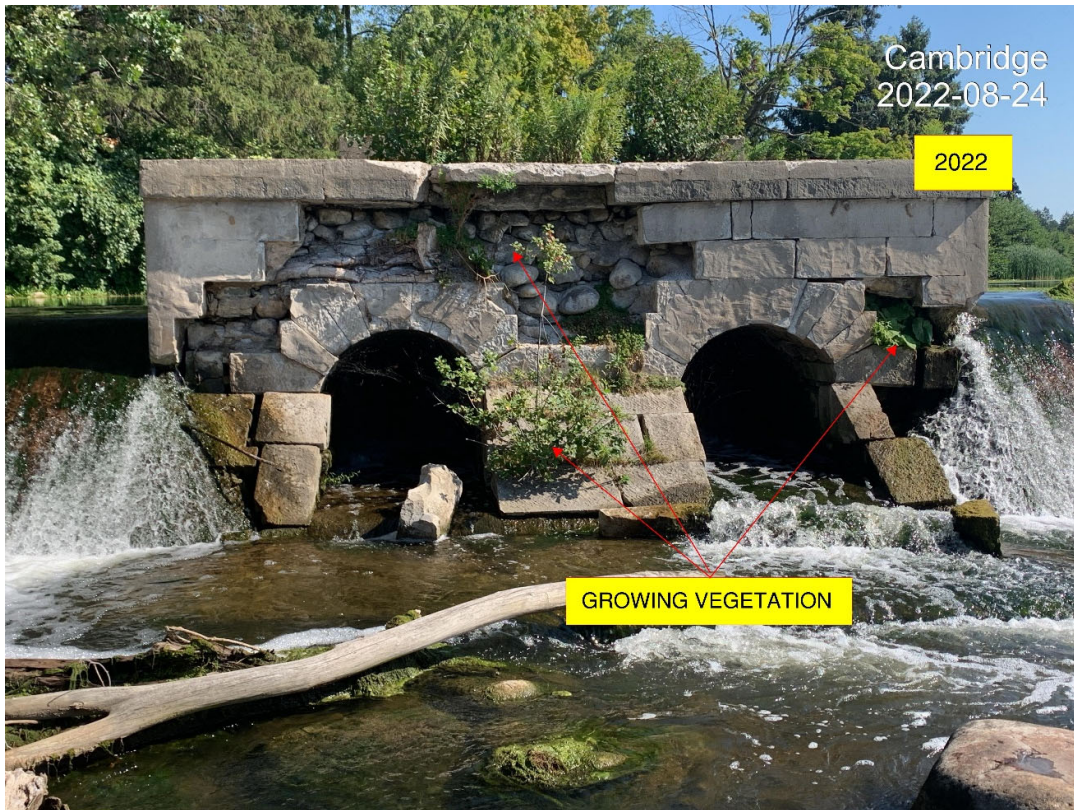
Photo 1 – North Stop Log Structure 2022
