**To:** Municipal Heritage Advisory Committee  
**Meeting Date:** 1/15/2026  
**Report Title:** **11 Kay Street – Recommendation to Designate**  
**Report Author:** Scott Abbott, Planner-Heritage  
**Department:** Planning and Growth  
**Division:** Policy Planning  
**Report No.:** 26-005 (MHAC)  
**File No.:** R01.01.194  
**Ward:** Ward 6

This report recommends that the property at 11 Kay Street be designated under Part IV, Section 29 of the *Ontario Heritage Act* for its cultural heritage value.

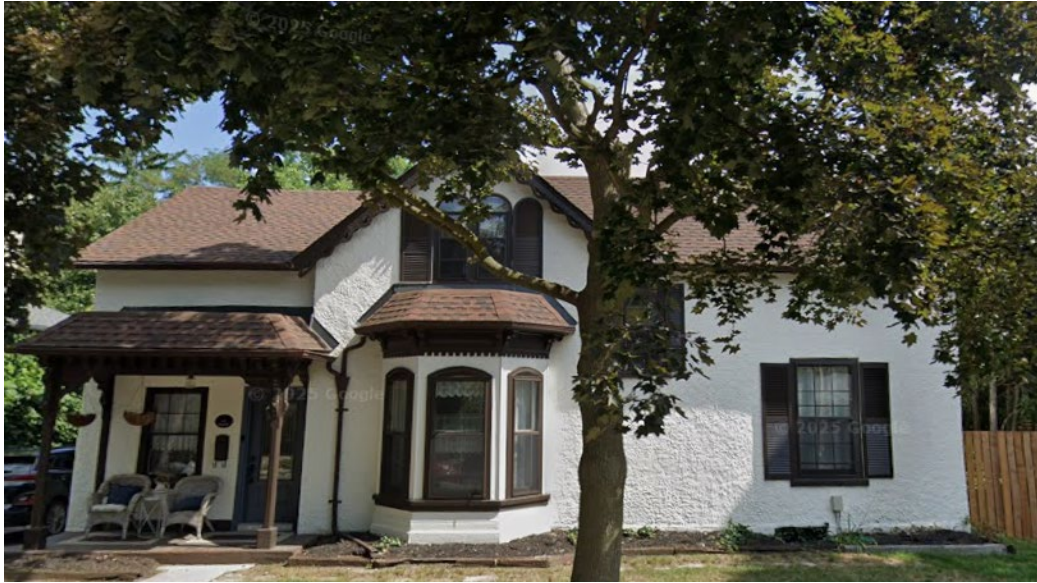
**Figure 1: Front Elevation of 11 Kay Street.**

View of the principal façade showing the one-and-a-half-storey dwelling with Gothic Revival-influenced features, including a steeply pitched front gable, decorative bargeboard and finial, bay window, rounded-arch window openings, and a covered porch. Later stucco cladding is visible.

- The dwelling at 11 Kay Street is a Gothic Revival–influenced residential building constructed between 1891 and 1914 (**Attachment C, Figure 1**).
- The property retains key architectural features that demonstrate design value and craftsmanship, despite later stucco cladding.
- Documentary evidence confirms occupancy by John Vanstone by 1914, with land title records indicating ownership in the mid-1910s.
- The dwelling supports the historic residential character of the Kay Street streetscape.
- The property meets four criteria (1, 2, 7, 8) under Ontario Regulation 9/06.

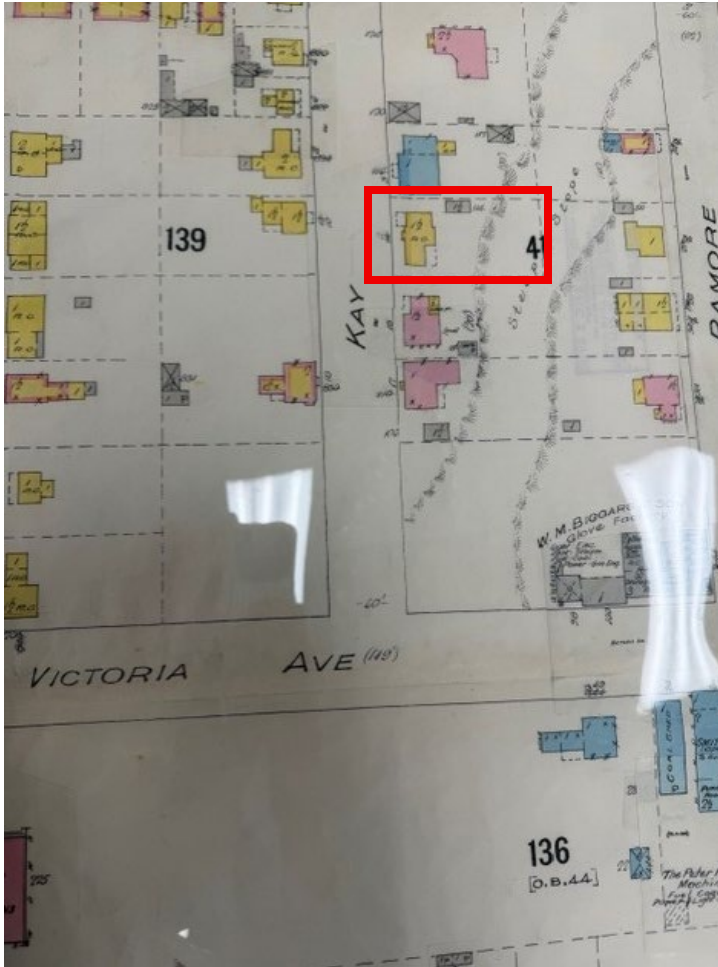
**Figure 2: 1910 Fire Insurance Map**

Fire Insurance map depicting the main dwelling in yellow, consistent with wood-frame construction, and a secondary accessory structure in grey, indicating masonry construction. Confirms the dwelling existed by 1910.

Census records indicate that John Vanstone, a former farmer from North Dumfries Township, was not residing in Galt in 1891 but had relocated to the town by 1901. This transition reflects a broader pattern of rural-to-urban migration during the period, as retired or semi-retired agricultural residents moved into urban centres such as Galt. Fire Insurance mapping from 1910 illustrates the presence of the dwelling at 11 Kay Street, confirming that the building had been constructed by that date (**Attachment C, Figure 2**). The main building is depicted in yellow, consistent with wood-frame construction, while a secondary accessory structure is shown in grey, indicating masonry construction.

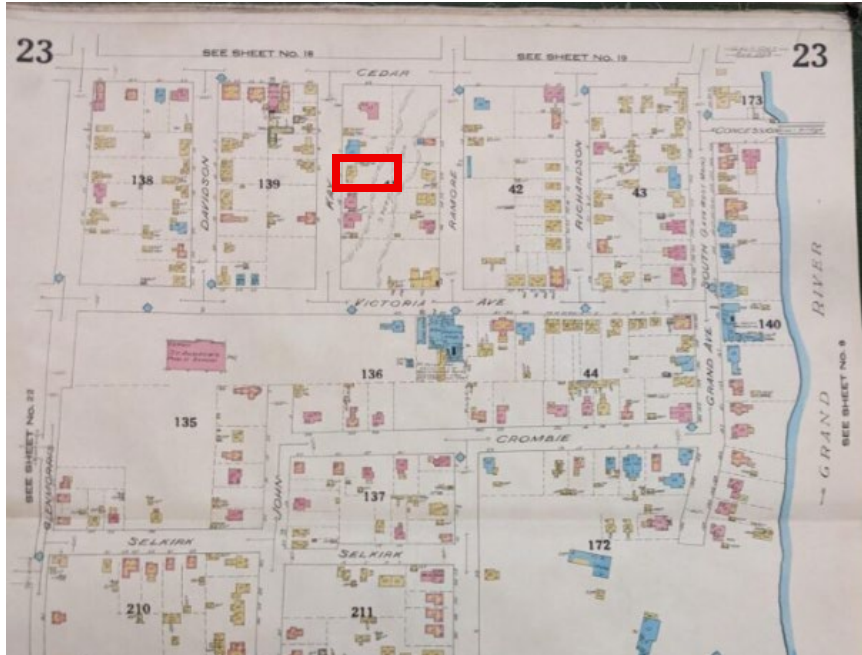
**Figure 6: 1929 Galt Fire Insurance Plan**

Fire insurance mapping illustrating the continued presence of the dwelling at 11 Kay Street and the established residential character of Kay Street by the late 1920s.
