Date: February 6, 2023
Project #: 60688869
From: Rick Bogaert
Roy Turner
Wael Mohamed Ali
Alex Penlington

Technical Memo

Subject: **Soper Park - Existing Washroom Building Assessment and Option Costs**

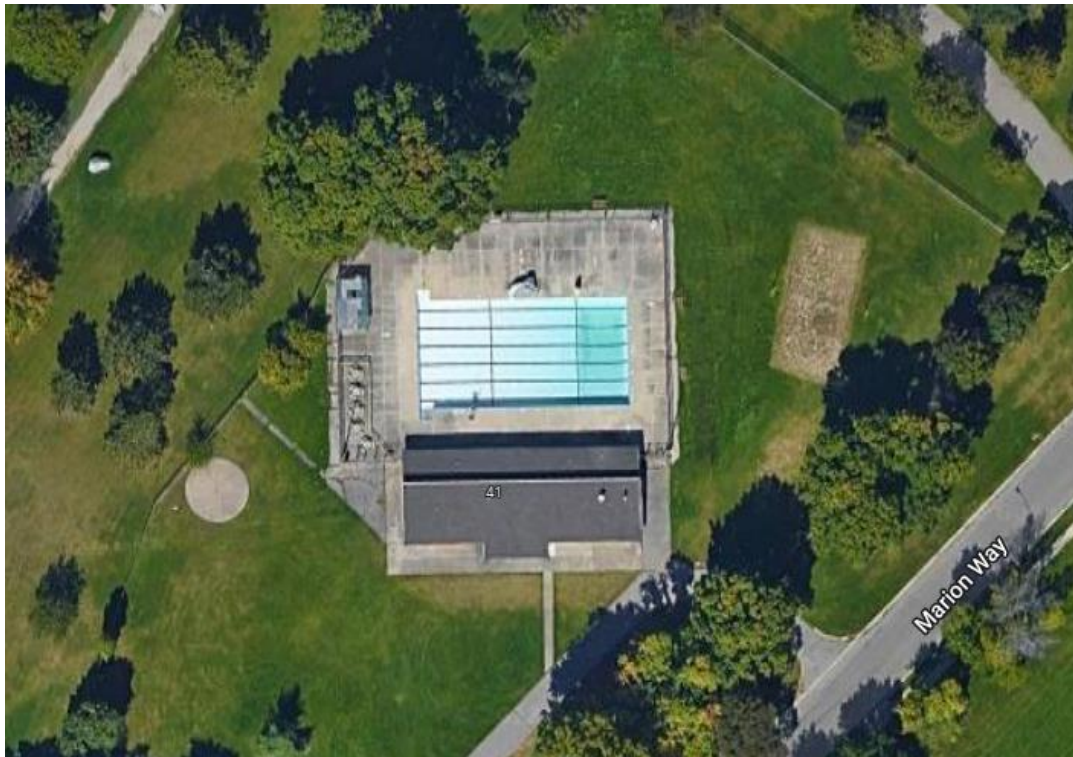
Figure 1: Soper Park Existing Washroom Building

Soper Park Washroom Building is located at 41 Marion Way in Cambridge. The City of Cambridge has demolished and removed the swimming pool and most of the concrete pool deck. The city is evaluating four building options. These include: full renovation; partial demolition and partial renovation; full demolition and re-build with a smaller building footprint; and full demolition with no re-build. The existing washroom building is shown in **Figure 1** below.

The existing single-story slab building (270 m²) building on grade is approx. 55 years old and is predominantly inner wythe block work with outer wythe brickwork. Its roof structure comprises two pitched sections each of wood rafters and shingles of ply decking with one ridge higher than the other leaving a vertical section of wall/clerestory glazing. There appears to be no roof insulation visible and due to age of construction would suspect little or none in the wall. Even though the potential use of this building could be seasonal, depending on the work proposed it may make sense to consider some insulation.

It is in reasonable condition for its age, but despite maintenance is showing signs of needed work.
